MILLARD BLUFF SLOPE STABILITY ANALYSIS

MILLARD PARK

Highland Park Lake County, Illinois

July 2, 2021

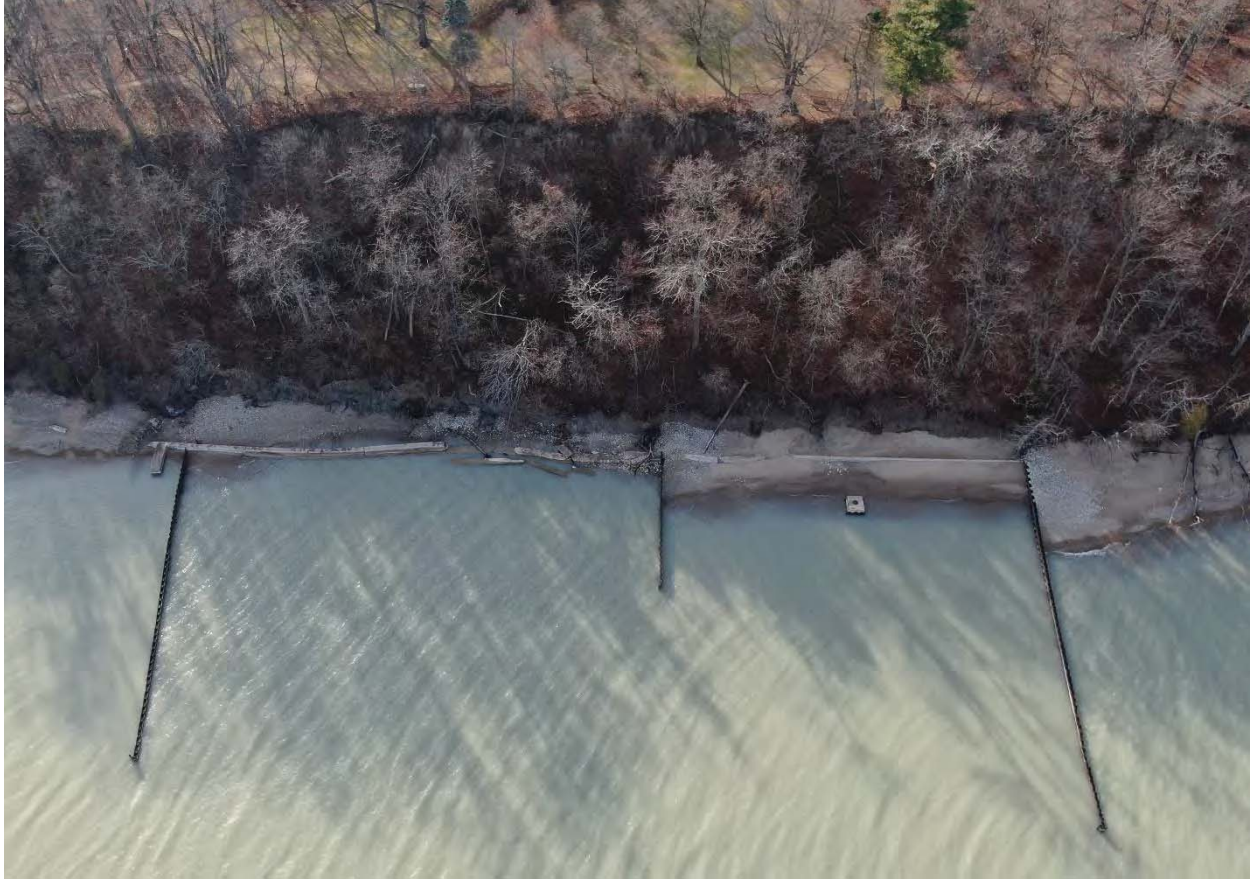
In addition to the sheet pile (jetty) walls a concrete seawall was constructed between the two main sheet pile jetties bounding Section B. Portions of the wall are damaged and allow overtopping water to flow back towards the lake, scouring out the sand behind the lowered concrete wall. Looking at aerial photos of this area (**Figure S.1** below) it is clear that in locations where the seawall is still intact the bluff appears to have somewhat less failure and erosion. Other than the sheet pile jetties and broken section of concrete wall, no existing structures appeared to be in place to prevent erosion at the toe of the bluff.

Figure S.1 Aerial Photo of the Seawall in Section B

The cost of concrete wall repair or sheet pile wall installation between Section B is estimated between \$25,000 and \$50,000 depending on choice of material and total length of wall repair.

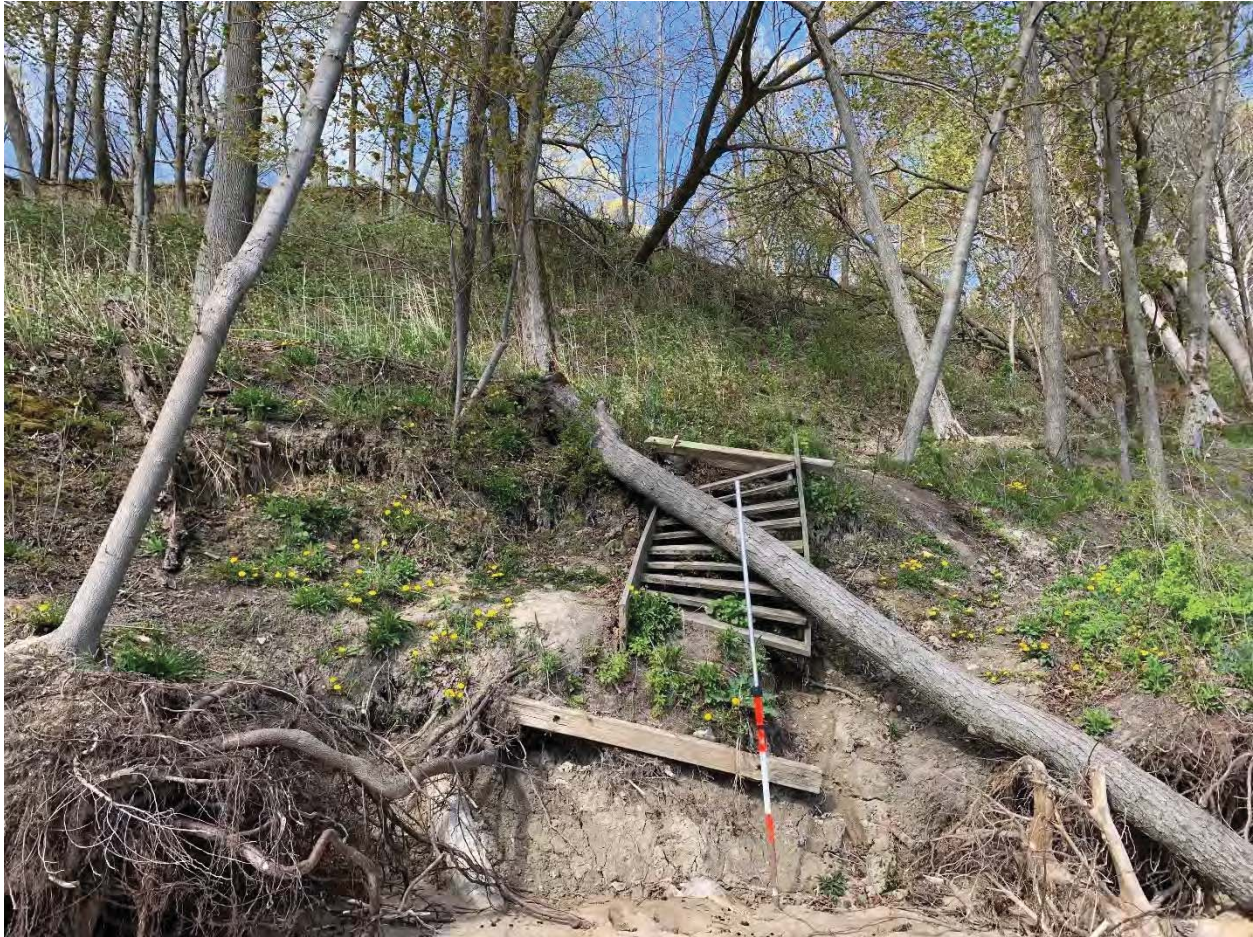
Figure 1.10 Destroyed stair access to beach – also a location expected to fail in the immediate future.

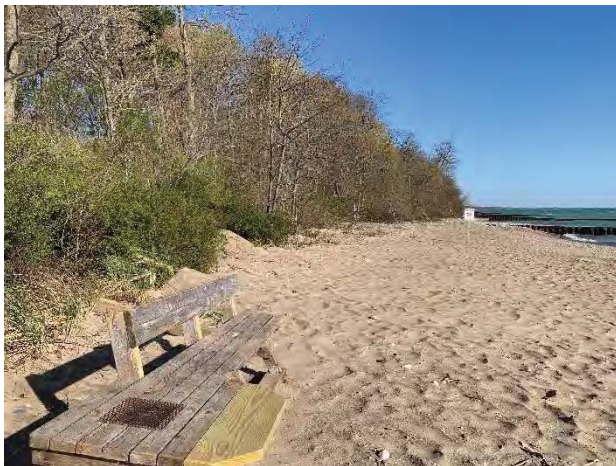
Starting from the south end of Millard Bluff the erosion was minimal and the slope was stable. The slope was measured to be just less than 2H:1V and there was a good amount of beachfront between the toe of the bluff and the edge of the lake (**Figure 2.10**).

Figure 2.10 South end of Millard Park with intact beach.

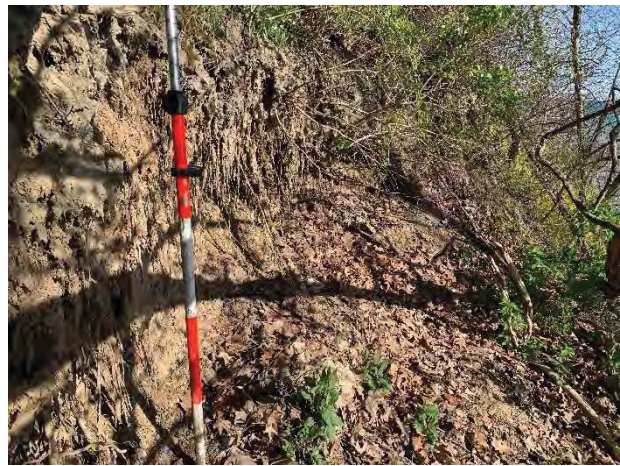
Progressing north along the bluff and up the trail, the slope steepens and the beachfront shrinks. V3 measured a slope of 4H:3.25V at the middle point of Section C where the bluff is unsafe to traverse. Just north of that slope measurement the first major slope failure occurs at the north end of Section C (**Figure 2.11**). This figure shows a vertical drop of about 5'. This slope failure came right up to the edge of the bluff with multiple trees overhanging the failure.

Figure 2.11 Slope failure at top of bluff on north end of Section C.

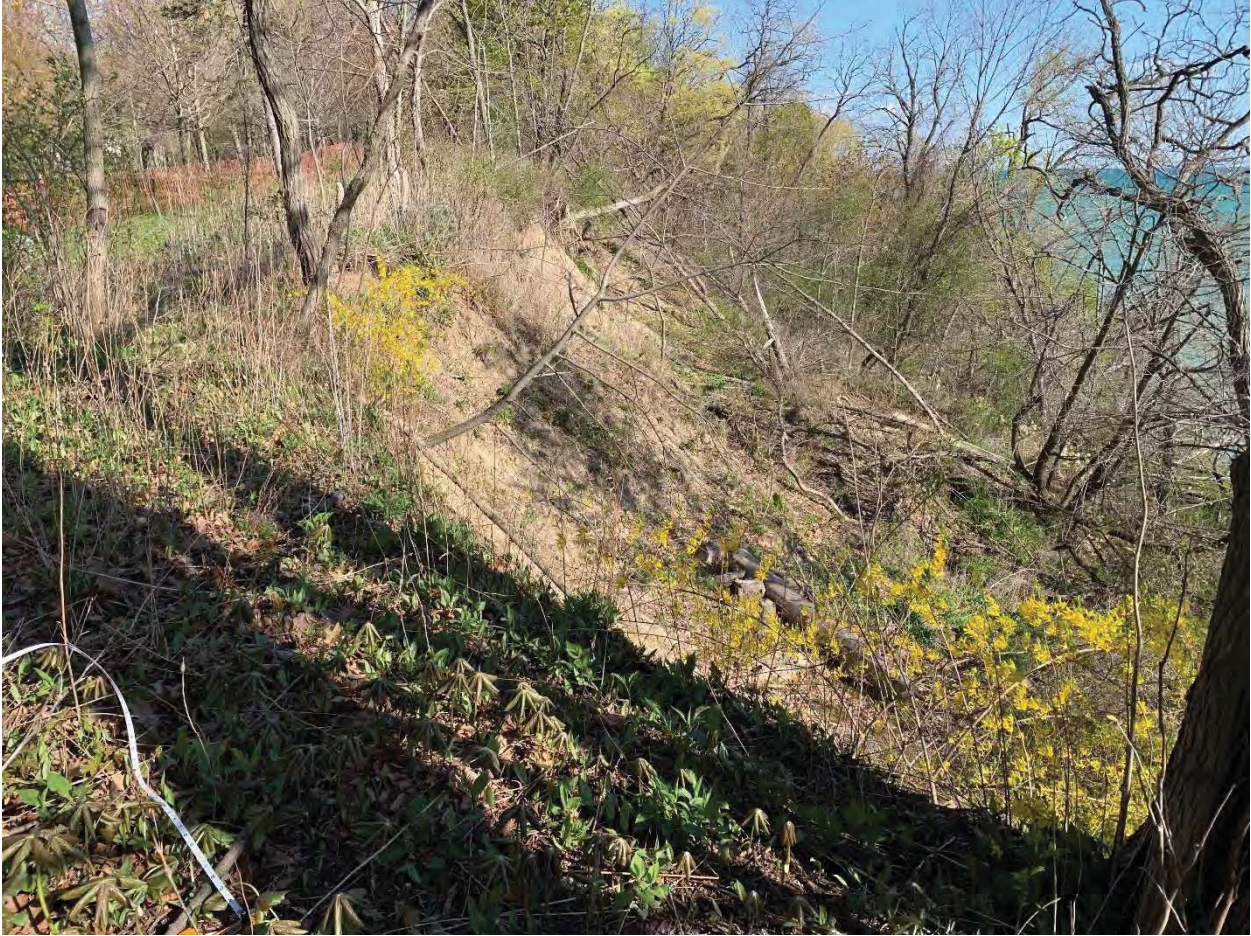
Section B was the worst section for bluff failure condition. Multiple large slope failures exist along the entire bluff. The south end and middle had slope failures with a vertical drop of almost 20' right up to the top of the bluff (**Figure 2.12**). It was not possible to acquire slope measurements at the bottom of these failures, however, it was clear from looking at the bluff that once a failure occurred the resulting slope was around a 2H:1V or even shallower. In fact, this sloughing was quite noticeable along the top of the bluff. There were clear areas where the slope was steep and had previously failed and below it the bluff leveled out until it reached another failure and the process repeated.

Figure 2.12 Large slope failure in Section B

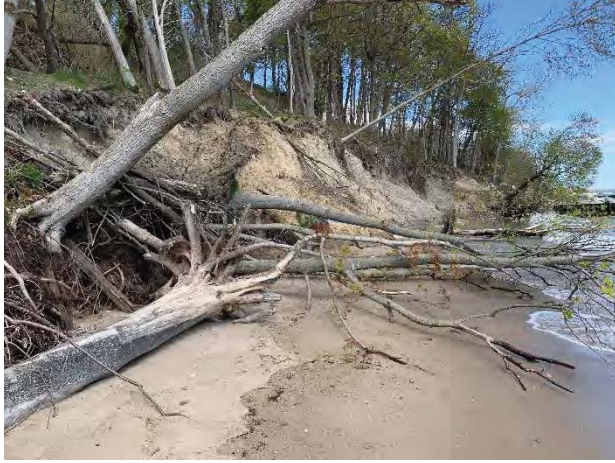
Figure 2.13 Bluff erosion along the beach in Sections A & B.

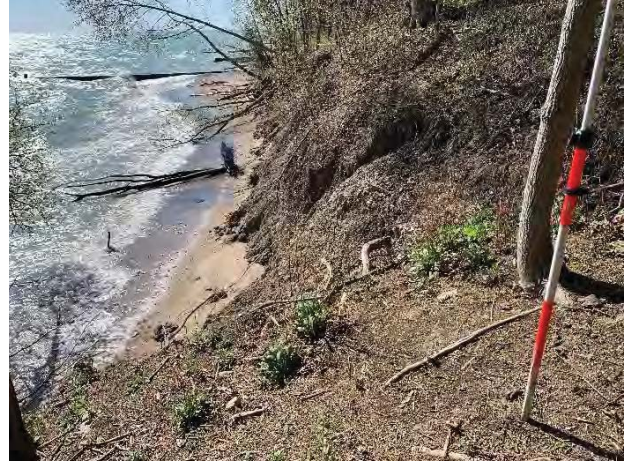
Figure 2.14 Major erosion at the very north end of Millard Park.

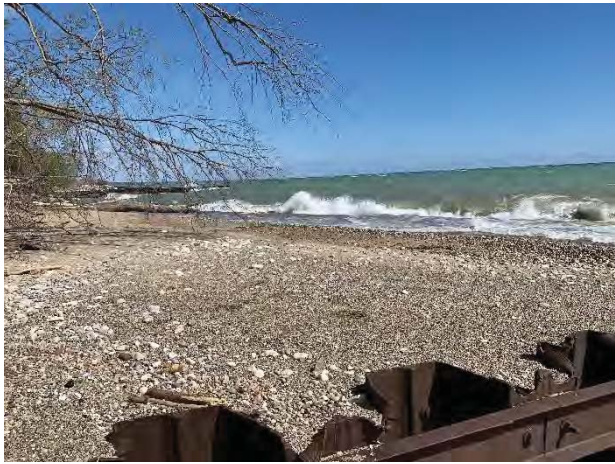
Figure 2.15 Beach front that had been protected due to the existing jetty.

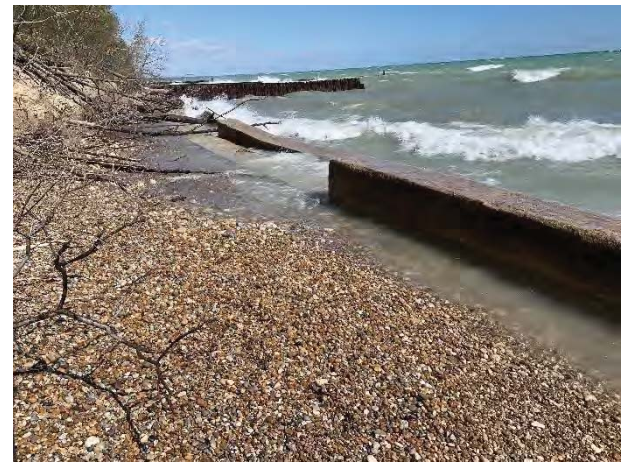
Figure 2.16 Scouring that is occurring behind the breached seawall.

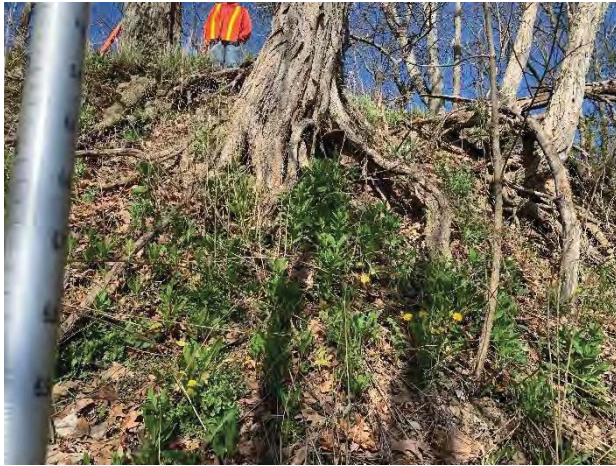
Along with erosion and slope failure V3 observed multiple trees in potential slope failure zones particularly at the top of the bluff. Over time the erosion in and around a tree can slowly remove the sand and soil around the root system, undermining the tree. This was especially evident towards the north end of Section C where V3 measured the 5' vertical drop that was caused by a slope failure (**Figure 2.21**). The tree undermining process was also visible, although to a less extreme extent, at the north end of Section A where the relict path came down the bluff face (**Figure 2.22**).

Figure 2.21 Exposed root system due to erosion at north end of Section C.

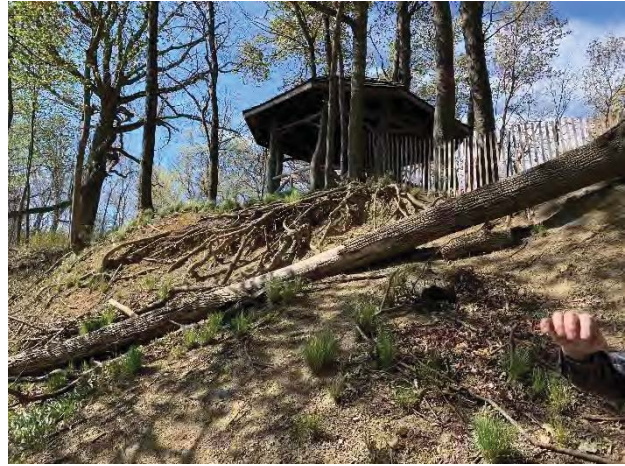
Figure 2.22 Exposed root system at the north end of Millard Park.

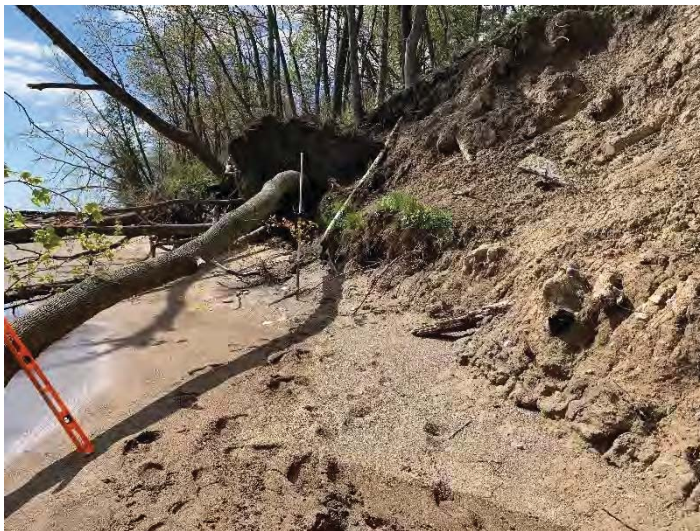
Figure 2.23 Fallen tree along the beach showing the uprooting that can occur.

Although trees and their root systems can often assist with slope stabilization, when they fail, they can contribute to larger and more significant slope failures. This is because the root ball and extra soil pulls out of the slope resulting in a larger failure zone. This could be seen along the beach front where trees had fallen onto the beach and large sections of bluff vegetation and topsoil were pulled away from the slope (**Figure 2.23**).

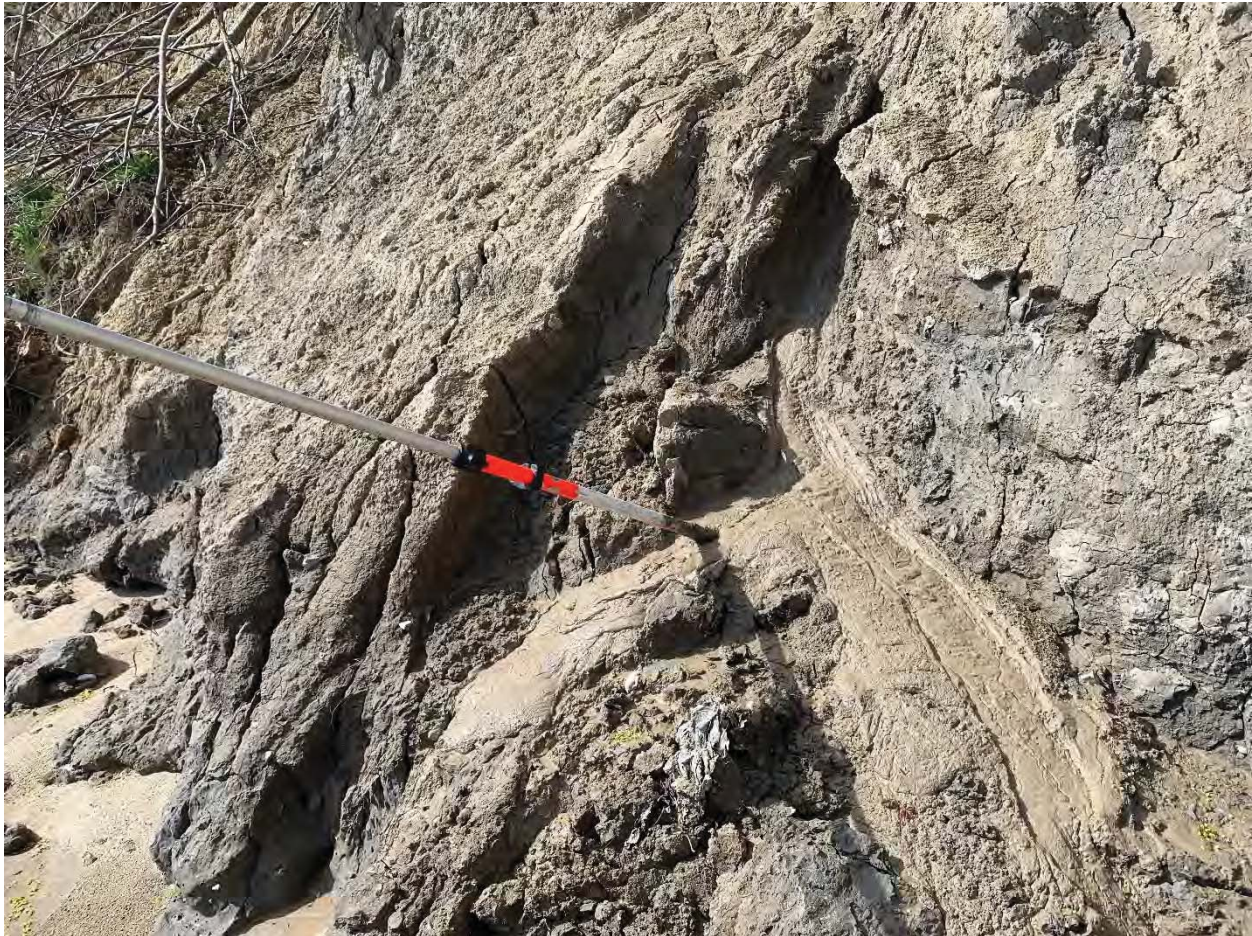
During times of heavy precipitation, or other saturating events, these sand layers can liquefy and flow down the bluff resulting in more erosion. Therefore the few existing locations of this interstratified sand layers is a benefit to stability of the Millard Bluff. Liquefaction can also occur to a lesser extent with the clay layers. During the site investigation along the beach, it was evident that subsurface saturation was indeed liquifying the soil and flowing out of the bluff (**Figure 2.31**). This type of erosion can be very dangerous due to the fact that it occurs below the surface and can go unseen until the slope finally fails.

Figure 2.31 *Liquifying soil seeping out the face of the bluff along the beach due to excessive soil saturation.*

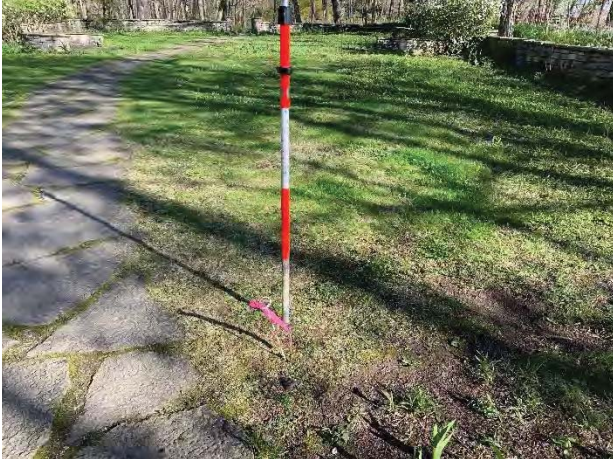
Figure 2.32 Sprinkler head at the top of the bluff on the south end of the flower garden.

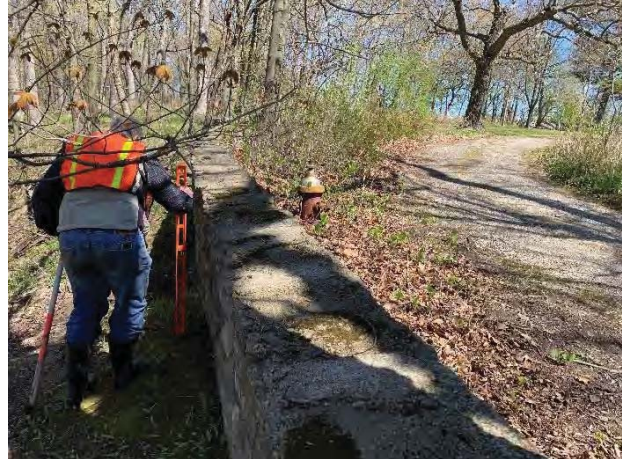
Figure 2.33 Fire hydrant at the northern end of Millard Park on the west side of the bluff.

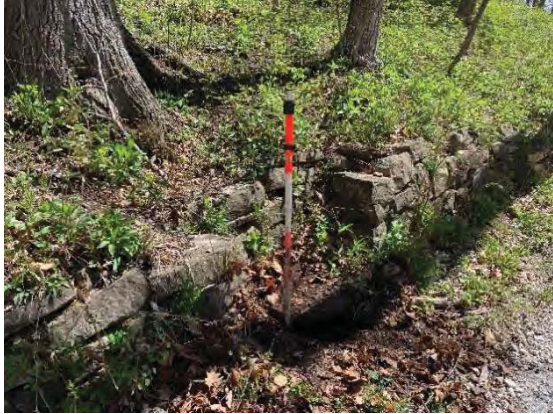
While inspecting the bluff multiple water structures were found that would lead V3 to believe there may be unnecessary water infiltration into the subsurface which could be contributing the soil saturation and erosion. Along the top of the bluff within the flower garden sprinkler heads were seen as well as a fire hydrant located north of the flower garden (**Figure 2.32** and **Figure 2.33**). V3 could not determine if either were still in use, but in the event that water was being provided to the area, it could be a culprit in regards to over-saturation of the subsurface soils. In addition to the observed water systems a storm sewer inlet was found on the west side of the bluff as well as a large structure east of the bluff in Lake Michigan (**Figure 2.34** and **Figure 2.35**). It could not be determined if the MWRD interceptor structure in Lake Michigan was used as an outlet for any of the Millard Park bluff drainage. It should be noted that along the bluff in areas of past failure sections the presence of broken clay pipe that would suggest some sort of drainage system was previously put in place to assist in subsurface drainage (**Figure 2.36**). If there was a drainage system previously put in place it would be a fair guess that past erosion has hindered, if not completely ruined, the effectiveness of the drainage system leading to more subsurface saturation.

Figure 2.34 Drainage inlet found along Millard Park path.

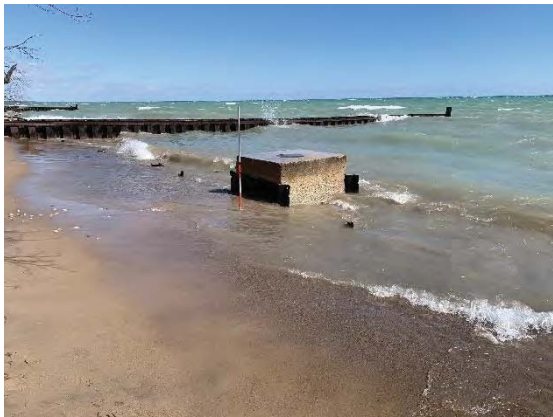
Figure 2.35 Probable MWRD interceptor sewer structure at bottom of bluff.

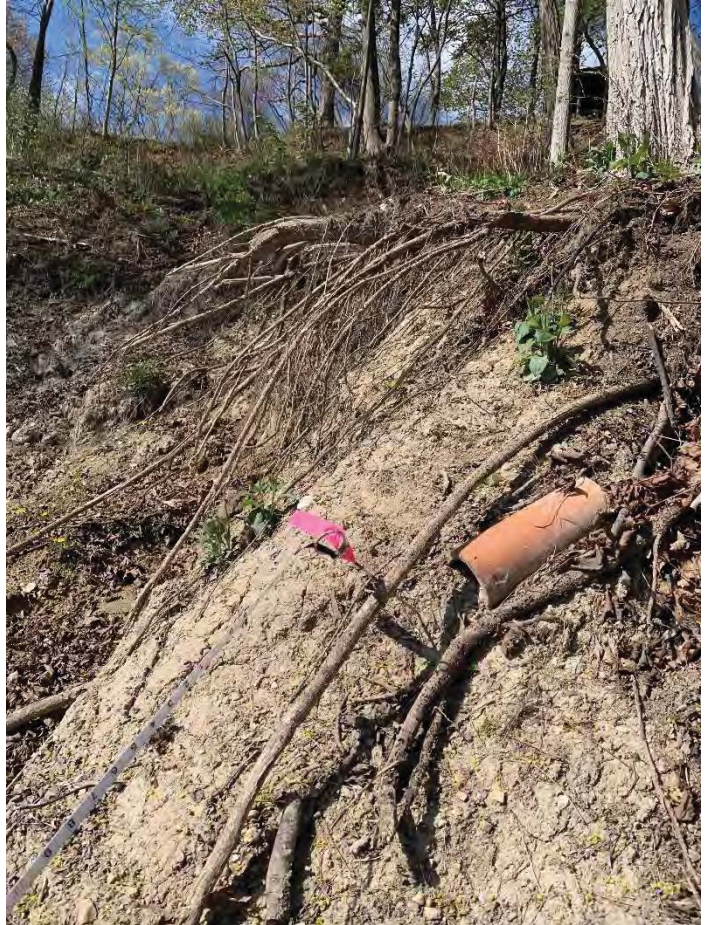
Figure 2.36 Piece of clay pipe. Possibly a section of an old drainage system.

Another consideration is the relict drainage and other utility structures that may be present, which may direct surface water to collect underground along the utility corridor, increasing local saturation causing local slope failure (and potentially leading to larger slope failures). It may be that **Figure 2.36** above illustrates this situation. Identification and assessment of these utilities should be performed at some time in the future to absolutely minimize water penetration causes of slope sloughing or failure. One such situation is the abandoned water system that should be checked for type of abandonment. If the pipe has been damaged and allows water entry and exit within the subsurface bluff soil layers, subsurface water accumulations can be happening without any obvious surface evidence. V3 noticed various broken sections of iron and clay pipe on the ravine and bluff faces.

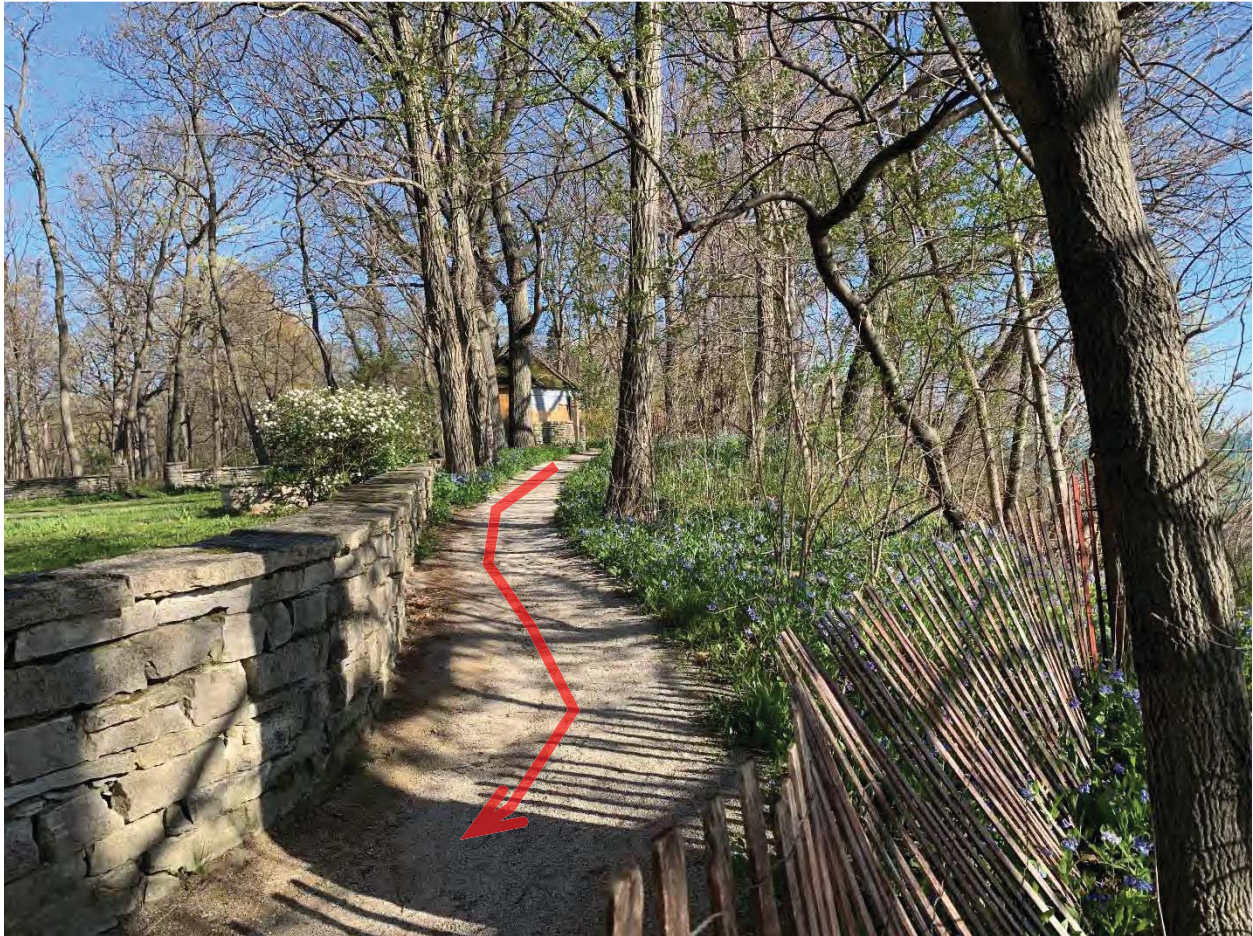
The top of bluff trail has been compromised and is expected to be relocated due to the high potential for future top of bluff edge slope sloughing and sliding failures. The slope stability report suggests the zone of potential failure could be as much as twenty feet back from the present top edge of bluff.

Figure 4.41 Existing top of bluff path being used to focus accumulations of drainage to bluff top edge

Therefore, V3 recommends relocation of the trail to an alignment a minimum of thirty feet back from the present top of bluff edge. As a part of this effort, V3 recommends re-grading of the previous path alignment where accumulated runoff drainage was inadvertently being directed to the edge of bluff (**Figure 4.41** below). This re-grading should be performed in such a manner as to direct the accumulated drainage to a more suitable outlet

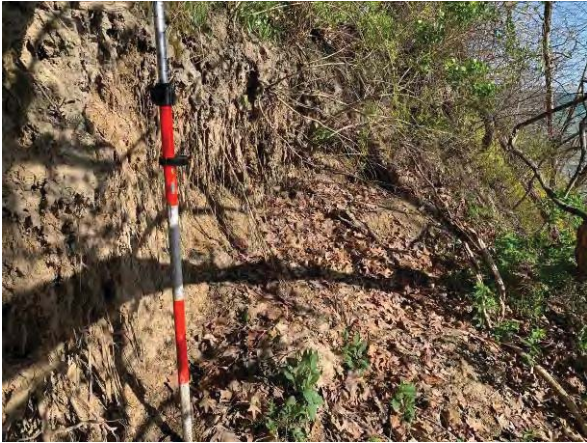
Picture 1: Vertical drop due to slope failure.

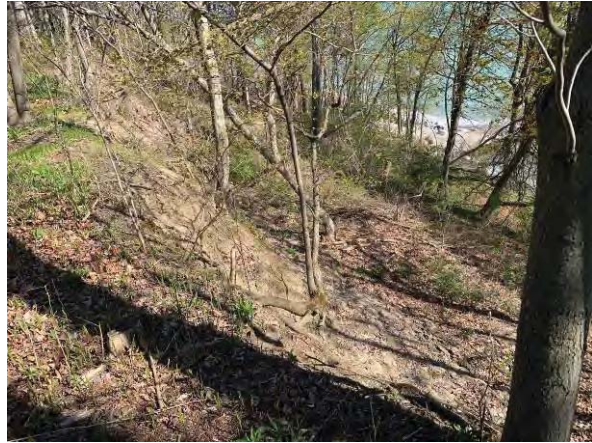
Picture 2: Slope Failure.

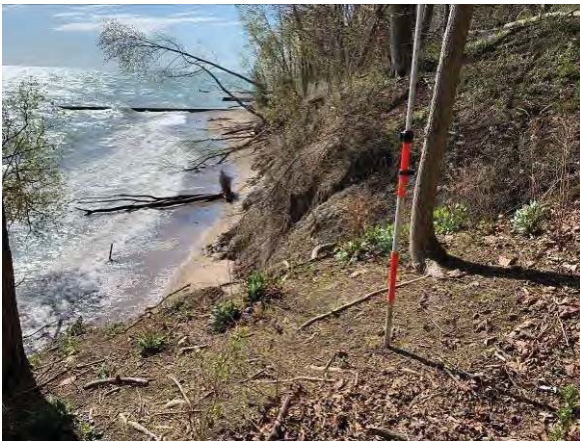
Picture 3: Major erosion and slope failure at beach.

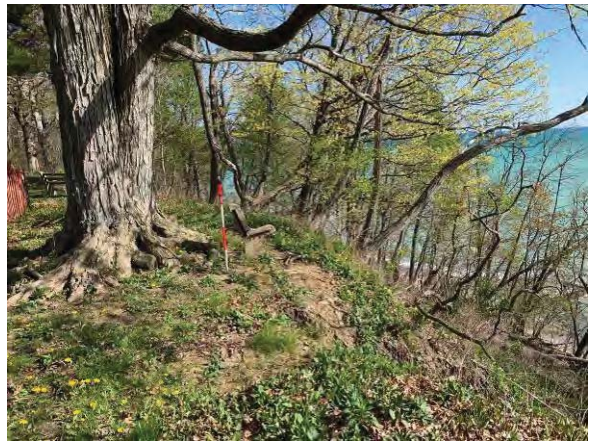
Picture 4: Tree in slope failure zone.

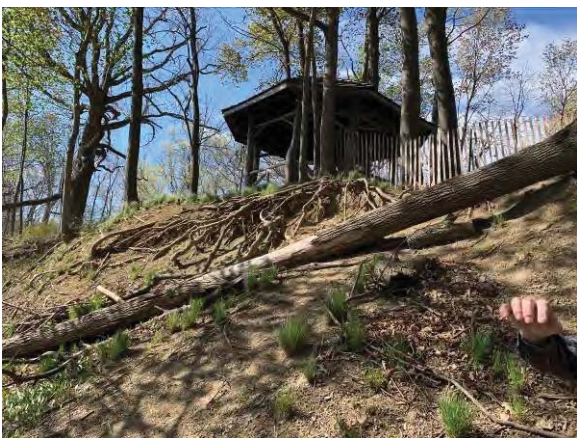
Picture 5: Exposed root system due to erosion.

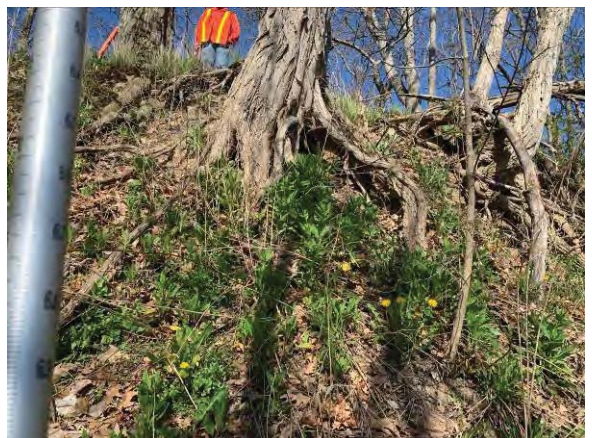
Picture 6: Exposed root system due to erosion.

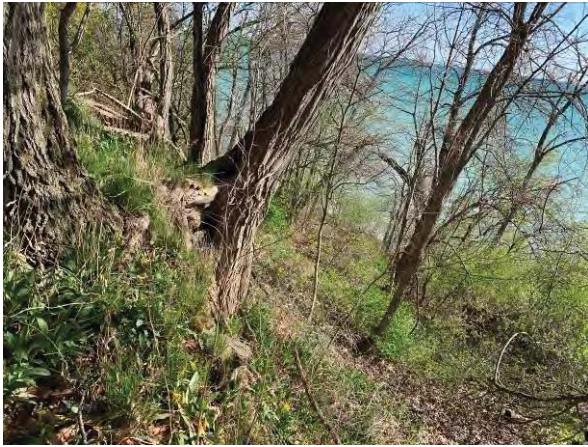
Picture 7: Tree in slope failure zone.

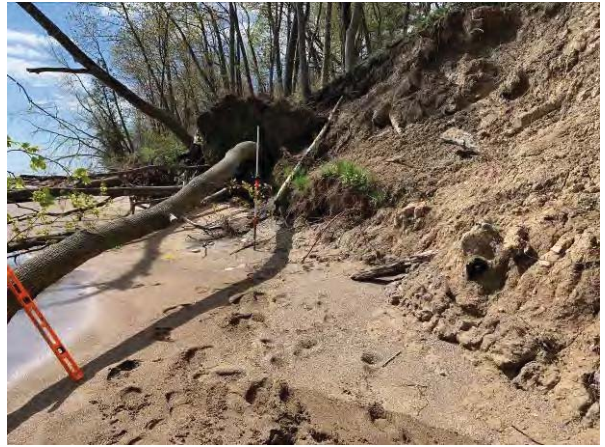
Picture 8: Tree failure showing uprooting.

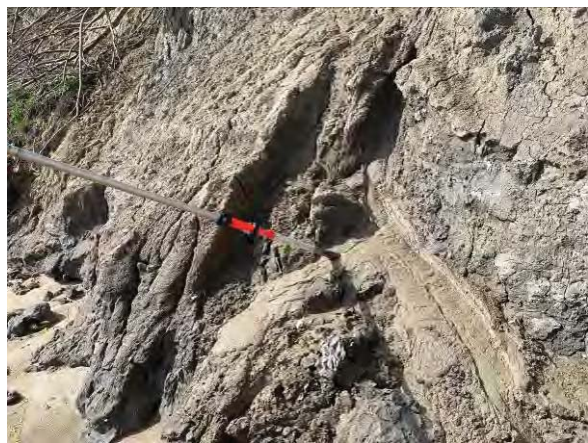
Picture 9: Soil seepage at base of bluff along beach.

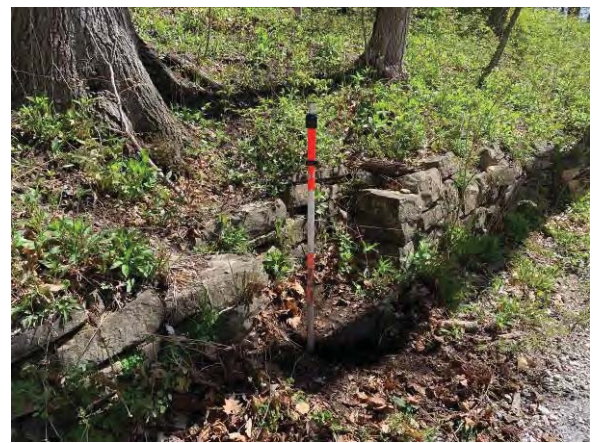
Picture 10: Storm sewer inlet.

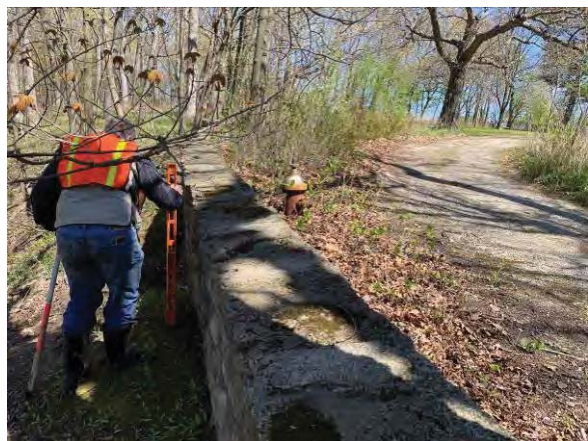
Picture 11: Fire hydrant still in use?

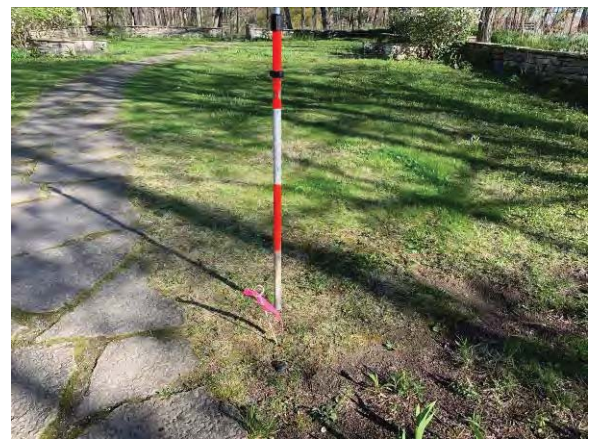
Picture 12: Sprinkler head still in use?

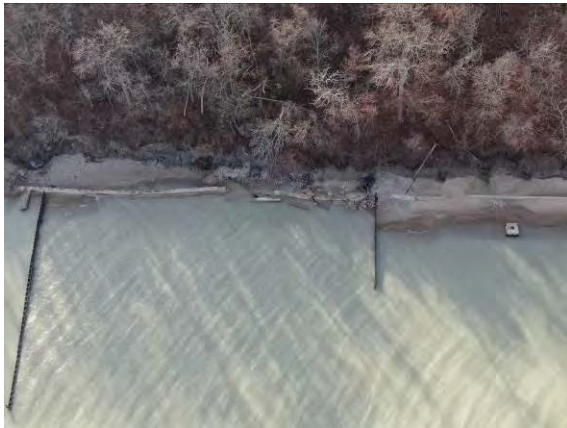
Picture 13: Aerial photo of deteriorating seawall on southern half of Section B.

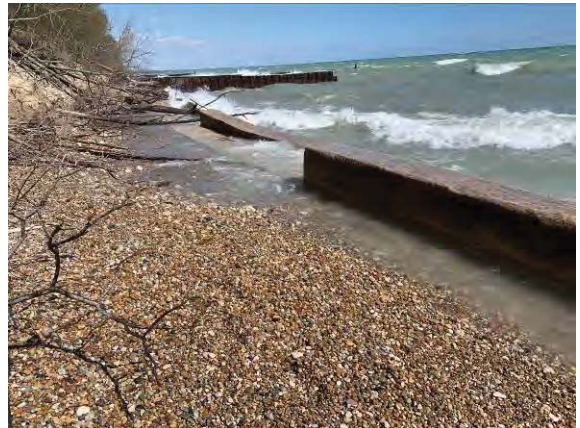
Picture 14: Washout occurring behind the seawall on the south of Section B.

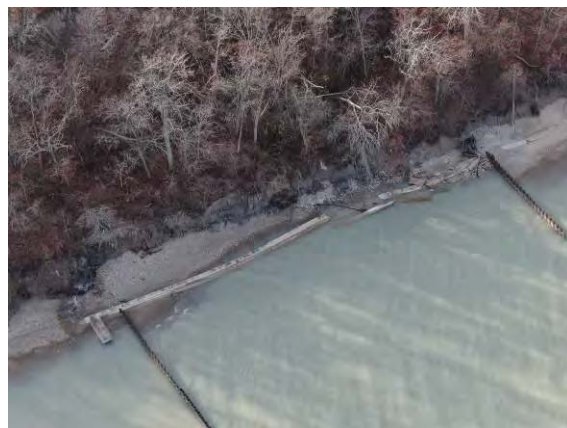
Picture 15: Slope failure behind seawall on south half of Section B.

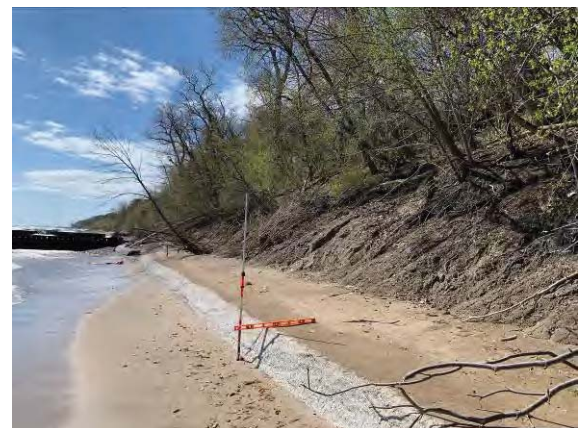
Picture 16: Priority Tree Removal area on north end of Section B looking south.

The necessary solution is to remove all at-risk trees to minimize weight and soil overturning pressure. Ideally removal of all trees for this particular bluff is recommended with the initial focus on high-risk trees mentioned above. By removing these trees, PDHP would be minimizing the risk of a storm or erosion knocking over the trees, causing larger slope failures. Over the course of time perhaps all bluff trees could be removed, but if not possible, then selective tree removal and ongoing management of trees on steeper slopes would be appropriate for this bluff face. For those locations where trees have already overturned and damaged the underlying soil layers, exposing the underlying clay to saturation and failure, V3 recommends re-grading of the local area, at a minimum, as discussed in the **Slope Grading** section below.

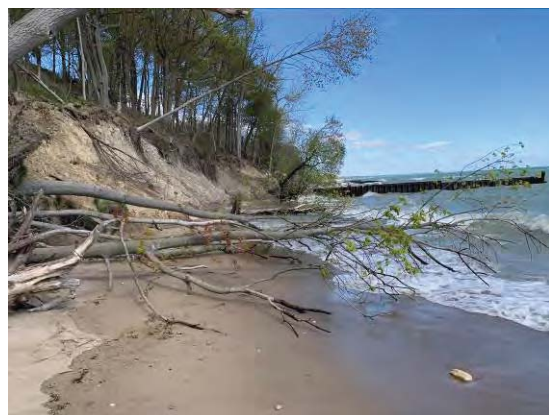
Picture 17: Priority Tree Removal area on south end of Section A looking north.

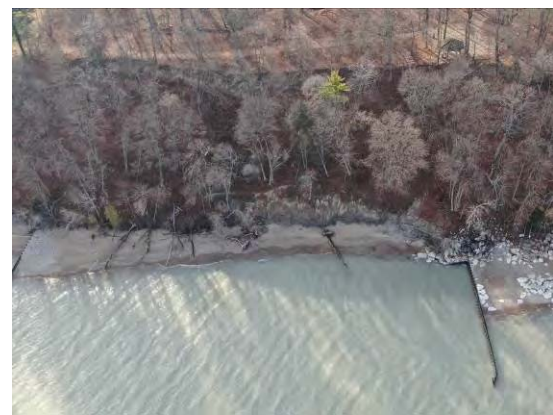
Picture 18: Aerial photo of slope failure on north end of Section A.

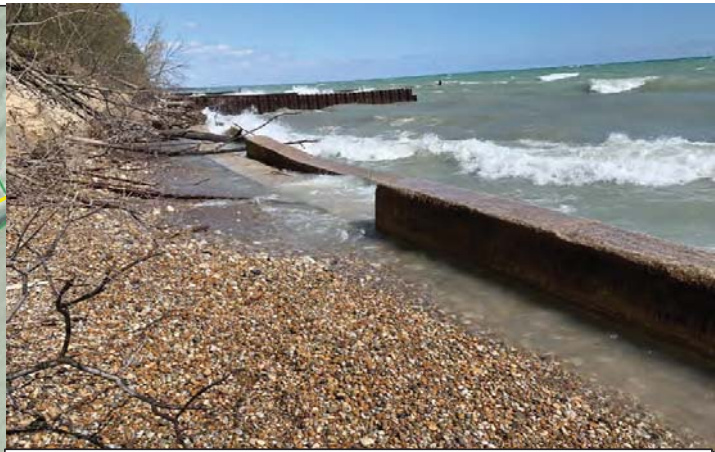
Photo 14: Photo of deteriorating seawall looking north along the beach

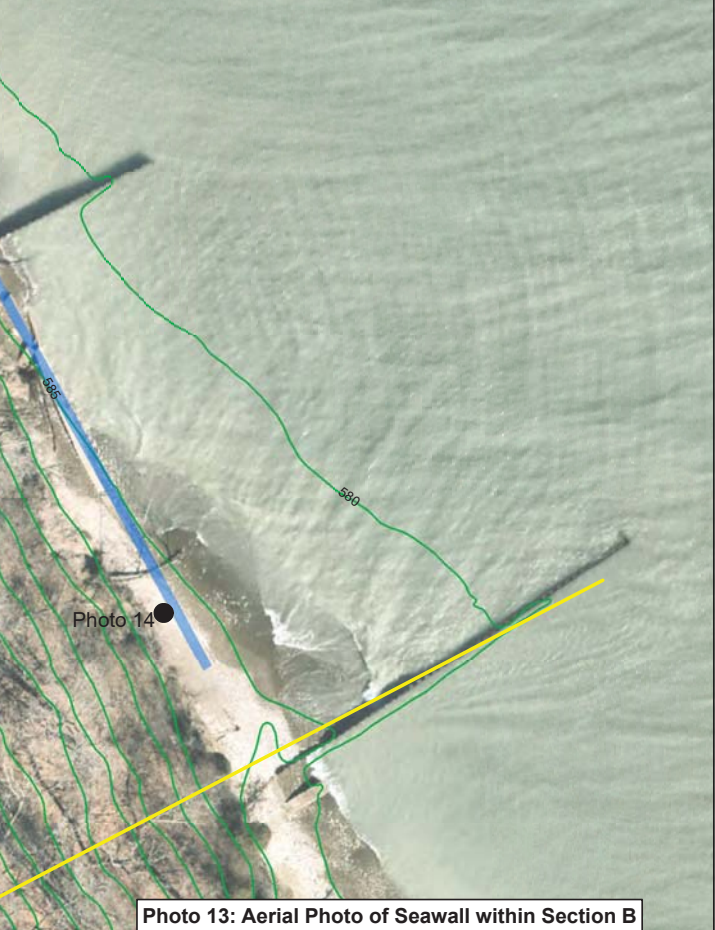
Photo 13: Aerial Photo of Seawall within Section B

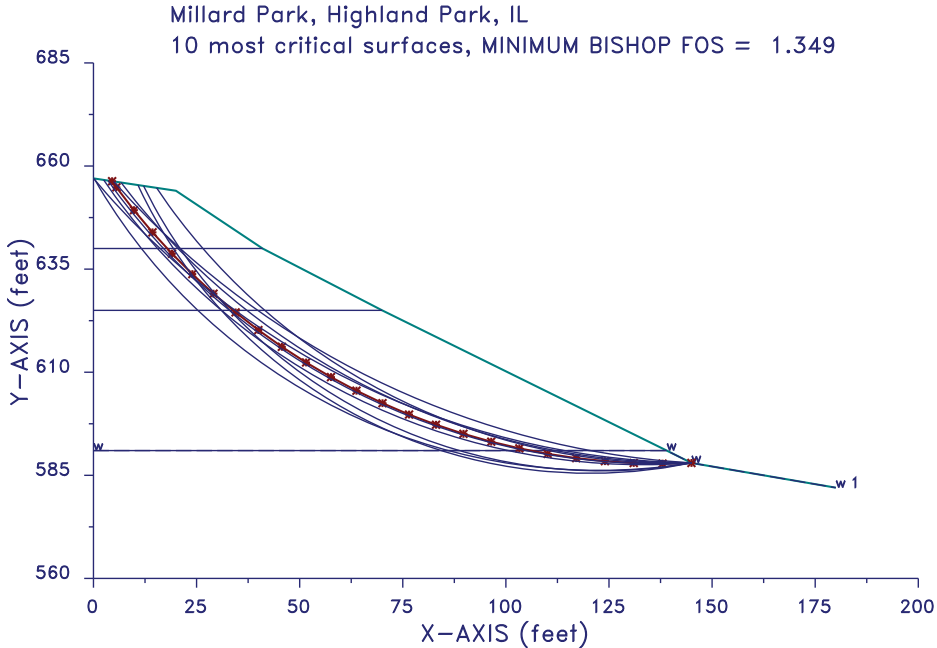
Normal Conditions OBA Job No. 21024

Case	Critical Factor of Safety (F.S.)
Bluff Stability - Normal (Dry) Condition	1.3
Bluff Stability - Wet (Saturated) Condition	0.9
Bluff Stability - Tension Crack (Saturated) Condition	0.9

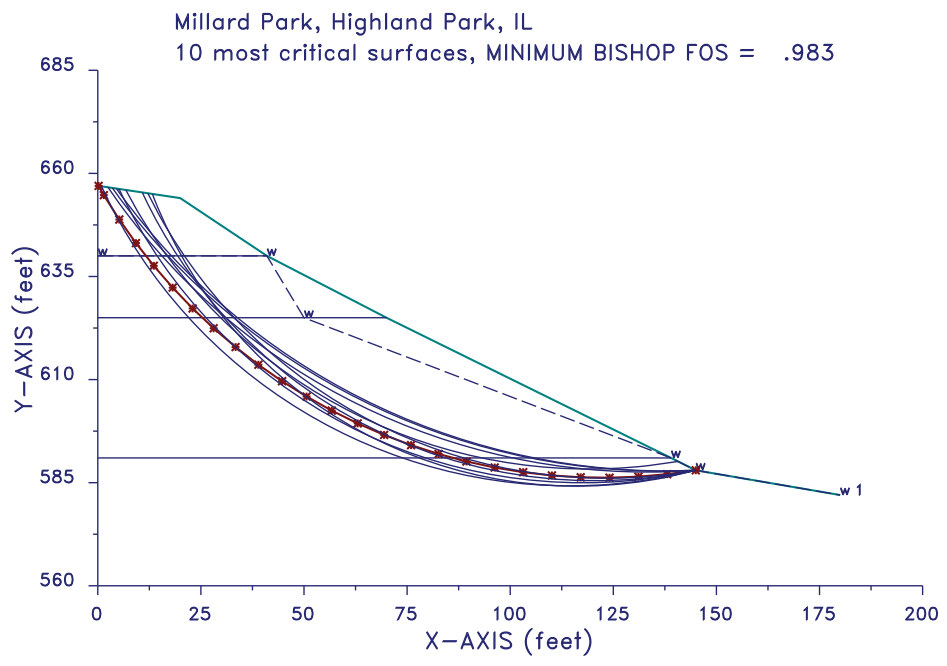
Saturated Conditions OBA Job No. 21024

The results of the slope stability analyses show factors of safety less than 1.0 for both the saturated and "cracked or tension" condition. These conditions, along with the erosion at the base of the bluff have likely occurred to varying degrees along the bluff and resulted in the failures are that now present at the site. Slope failure is difficult to predict because of the local variation in soil and groundwater conditions, weather conditions and lake levels, and the type and amount of vegetation that is present on the bluff. And obviously, for current conditions where steeper slopes are present, the factor of safeties should be considered marginal at best. More defined slope stability analyses can be performed, but these would require a more accurate and up to date site topography.
