PARK DISTRICT OF HIGHLAND PARK

BEACH MANAGEMENT PLAN

March 2021

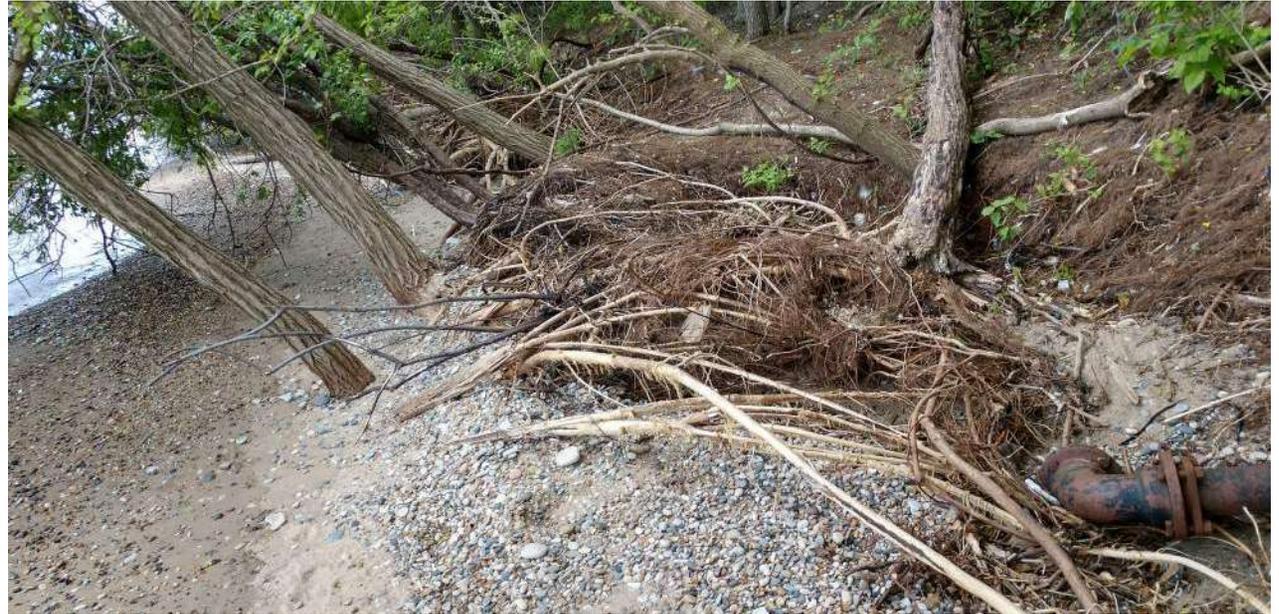
Figure 2.10 Root Exposure Caused by Wave Action Along the Bluff Toe

However, as referenced, the toe of the bluff is experiencing a direct wave attack due to high water levels. This has led to erosion of the toe and around the tree roots which may lead to overall bluff instability. This will not self-repair once lake levels recede.

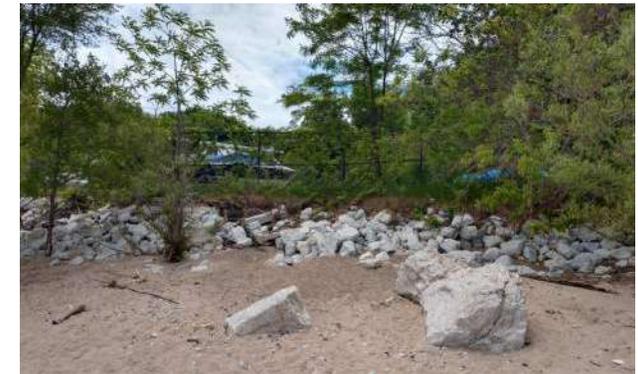
Figure 2.15 Remnant revetment stones on the north beach

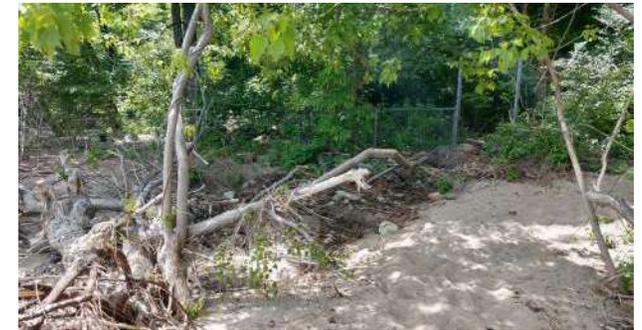
Figure 2.26 Residential discharge channel across beach.

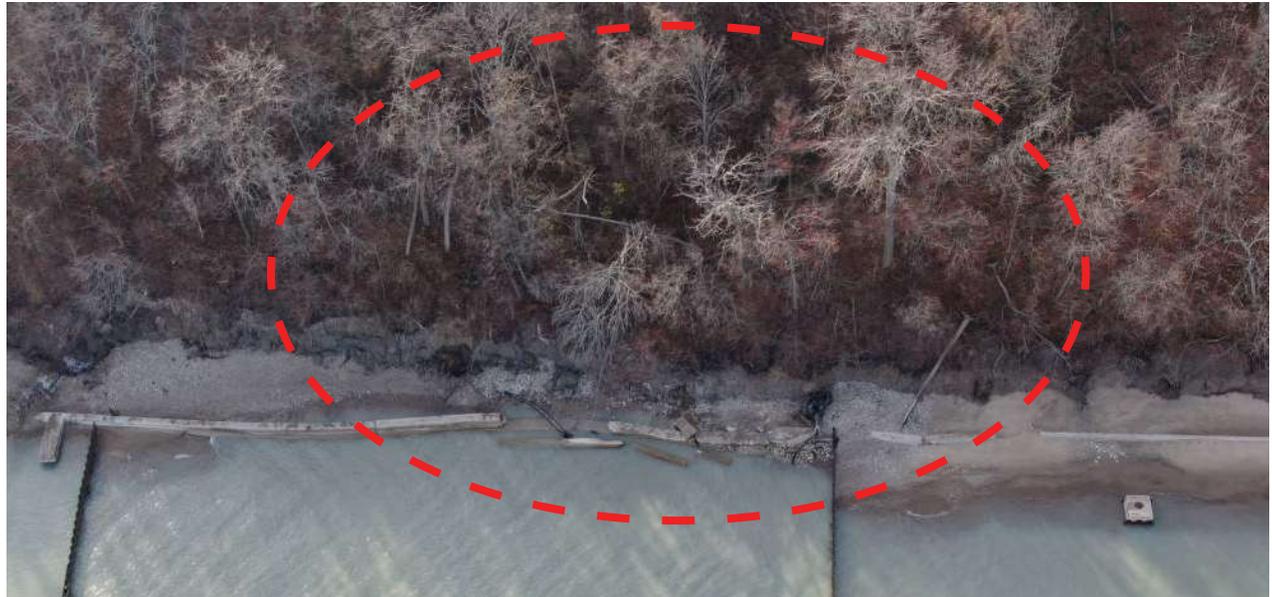
The high-water levels of 2019 & 2020 resulted in segments of bluff failure between the first and fourth groin. The compromised toe exhibits an almost vertical face which is inherently unstable. Vegetation roots are fully exposed in some areas. While the primary cause of the bluff failure was wave attack at the toe and ground saturation, the dense tree canopy cover and open soft sediments contributed to the failure. Bluff face vegetation will continue to pull on the topsoil layer exposing the soft sediments below. The combination of weakening of vegetation roots as the plant withers and stormwater cutting into the soft soils will lead to a full bluff face collapse as the slope attempts to correct itself back to a stable position. This can happen immediately or may take years but without intervention, the current slope will break and slump.

Figure 2.27 Aerial Photo of Bluff Failure, Late Fall 2020.

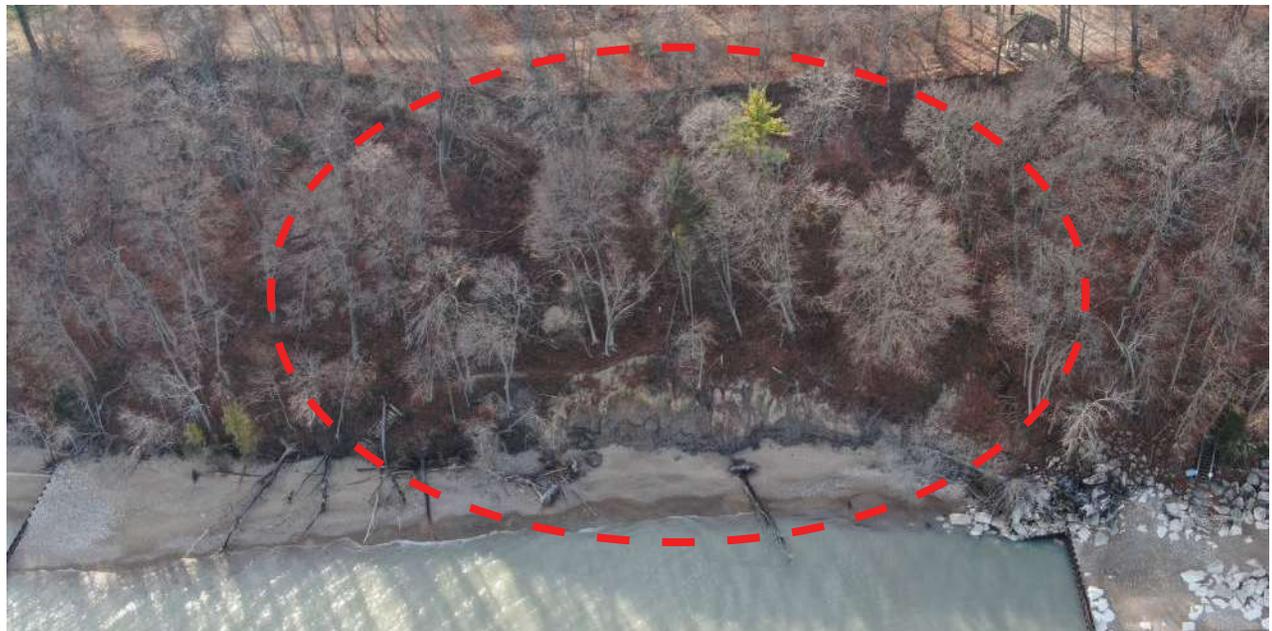
Figure 2.28 Aerial Photo of Bluff Subsidence, Late Fall 2020.

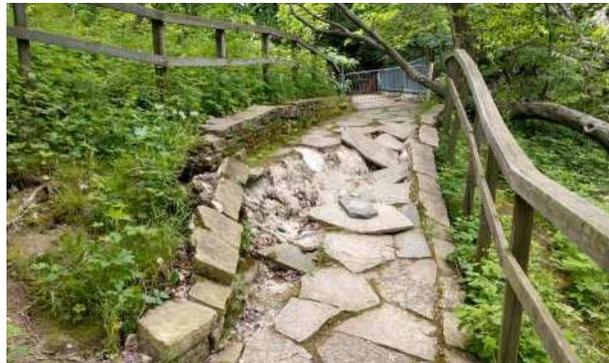
Finally, the existing wooden stairs from the top of bluff in Moraine Beach to ravine bridge crossing should be replaced. During the site inspection of this beach the stairs were found to be mushy, split, and face rotting in places.

Figure 4.1 Collapsed trail to Moraine beach

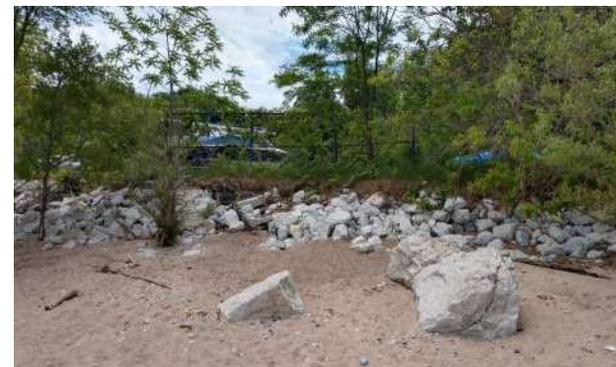
Figure 4.2 Remnant revetment stones on the north beach

The parking lot at the North Shore Yacht Club needs to be restored and protected. Depending on the type of scour protection developed permitting will be required. An evaluation of the expected permitting should be prepared as part of the design for the scour protection.
