PARK DISTRICT OF HIGHLAND PARK

BEACH MANAGEMENT PLAN

March 2021

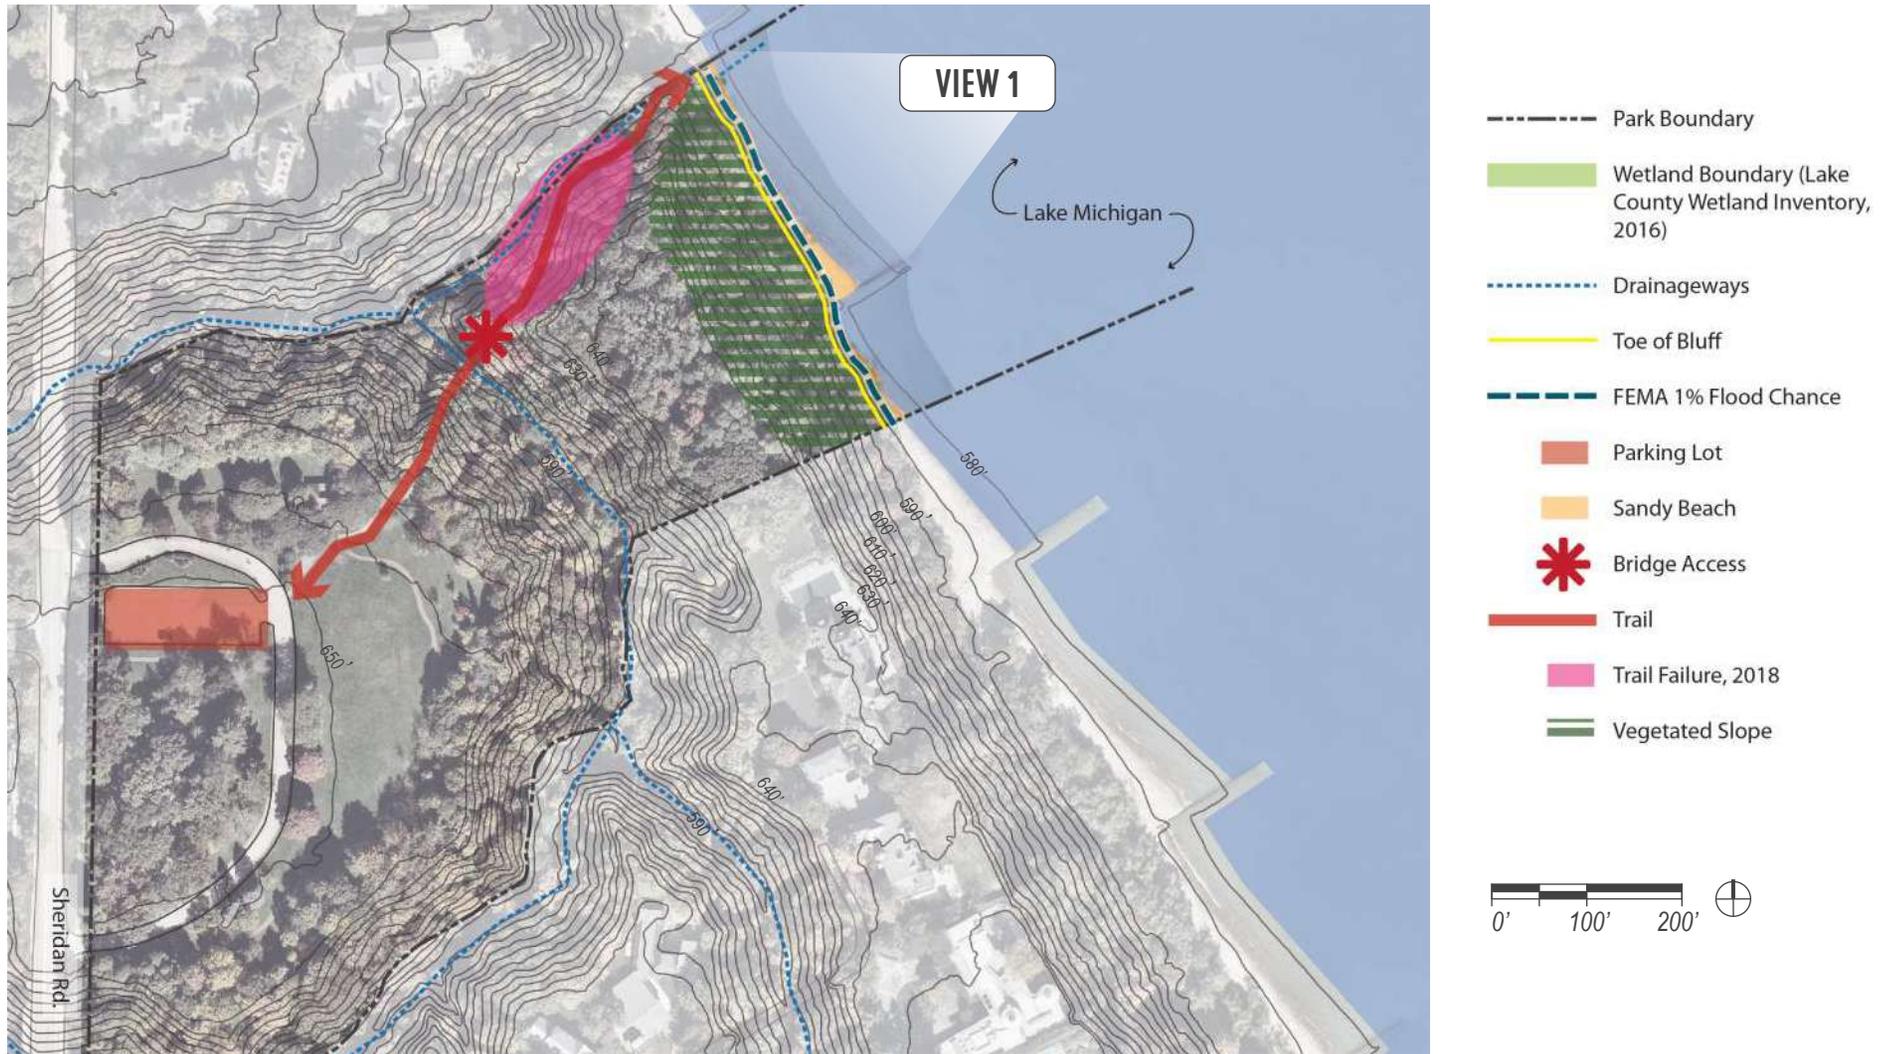
Figure 2.9 Existing Conditions at Moraine Beach

The beach is a gently sloping sand beach at approximately a 10H:1V slope, steepening to a 6H:1V slope before hitting the steeply rising vegetated bluff that backs the west edge of the beach. The bluff rises steeply from the beach at approximately a 2H:1V slope. The toe of the bluff, where the grade sharply steepens, is located along the 590 contour.

At the time of this study, the edge of vegetation appeared to be located along the 587 contour. Historical imagery shows the edge of vegetation shifts between the 586 and 590 contours which is likely a result of varying water levels and storm damage.

Because of the high lake water levels of 2019 - 2020, the dry portion of Moraine beach is narrow, only 10-12' in width, backed by a thick wall of vegetation at the base of the bluff. Scrub tree species from the bluff have invaded the beach and along much of the length of the beach. The roots of these trees were exposed during the 2020 site visit which is evidence of wave attack during storms (Fig 3.10). As a result, many trees along

the sandy interface have fallen or are pitched toward the lake making walking on the beach during high water impossible without entering the water. Cutting of the bluff toe and removal of this soft sediment is an indication of future bluff instability issues even after lake levels recede.

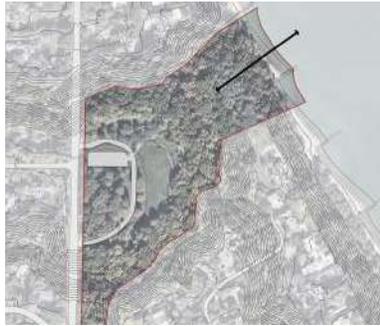
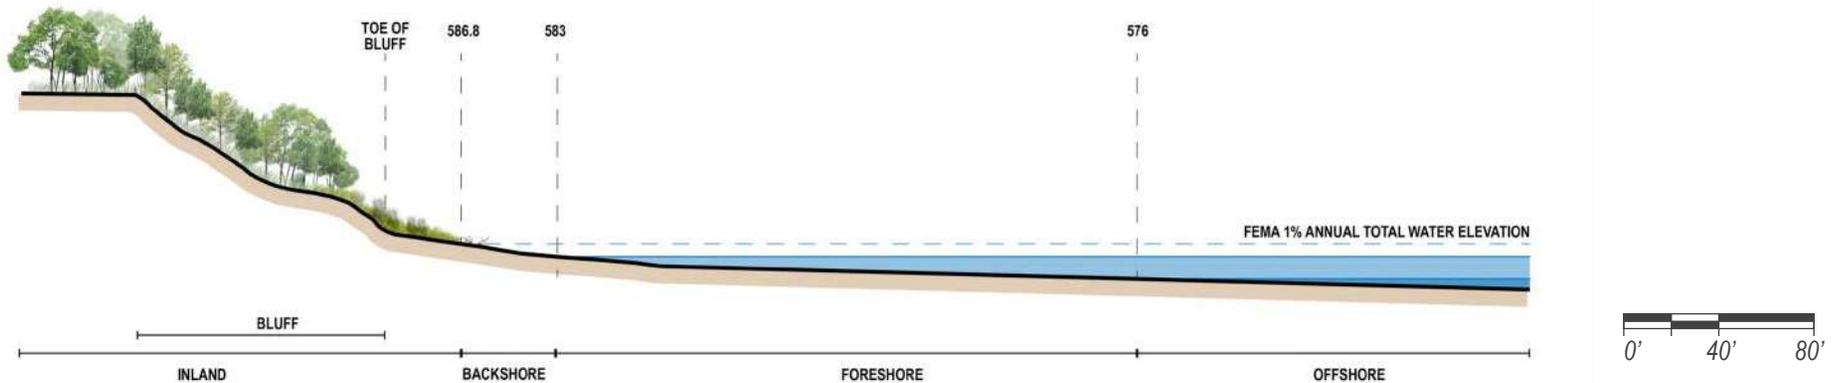
Figure 2.11 Cross Section of Moraine Beach

However, as referenced, the toe of the bluff is experiencing a direct wave attack due to high water levels. This has led to erosion of the toe and around the tree roots which may lead to overall bluff instability. This will not self-repair once lake levels recede.

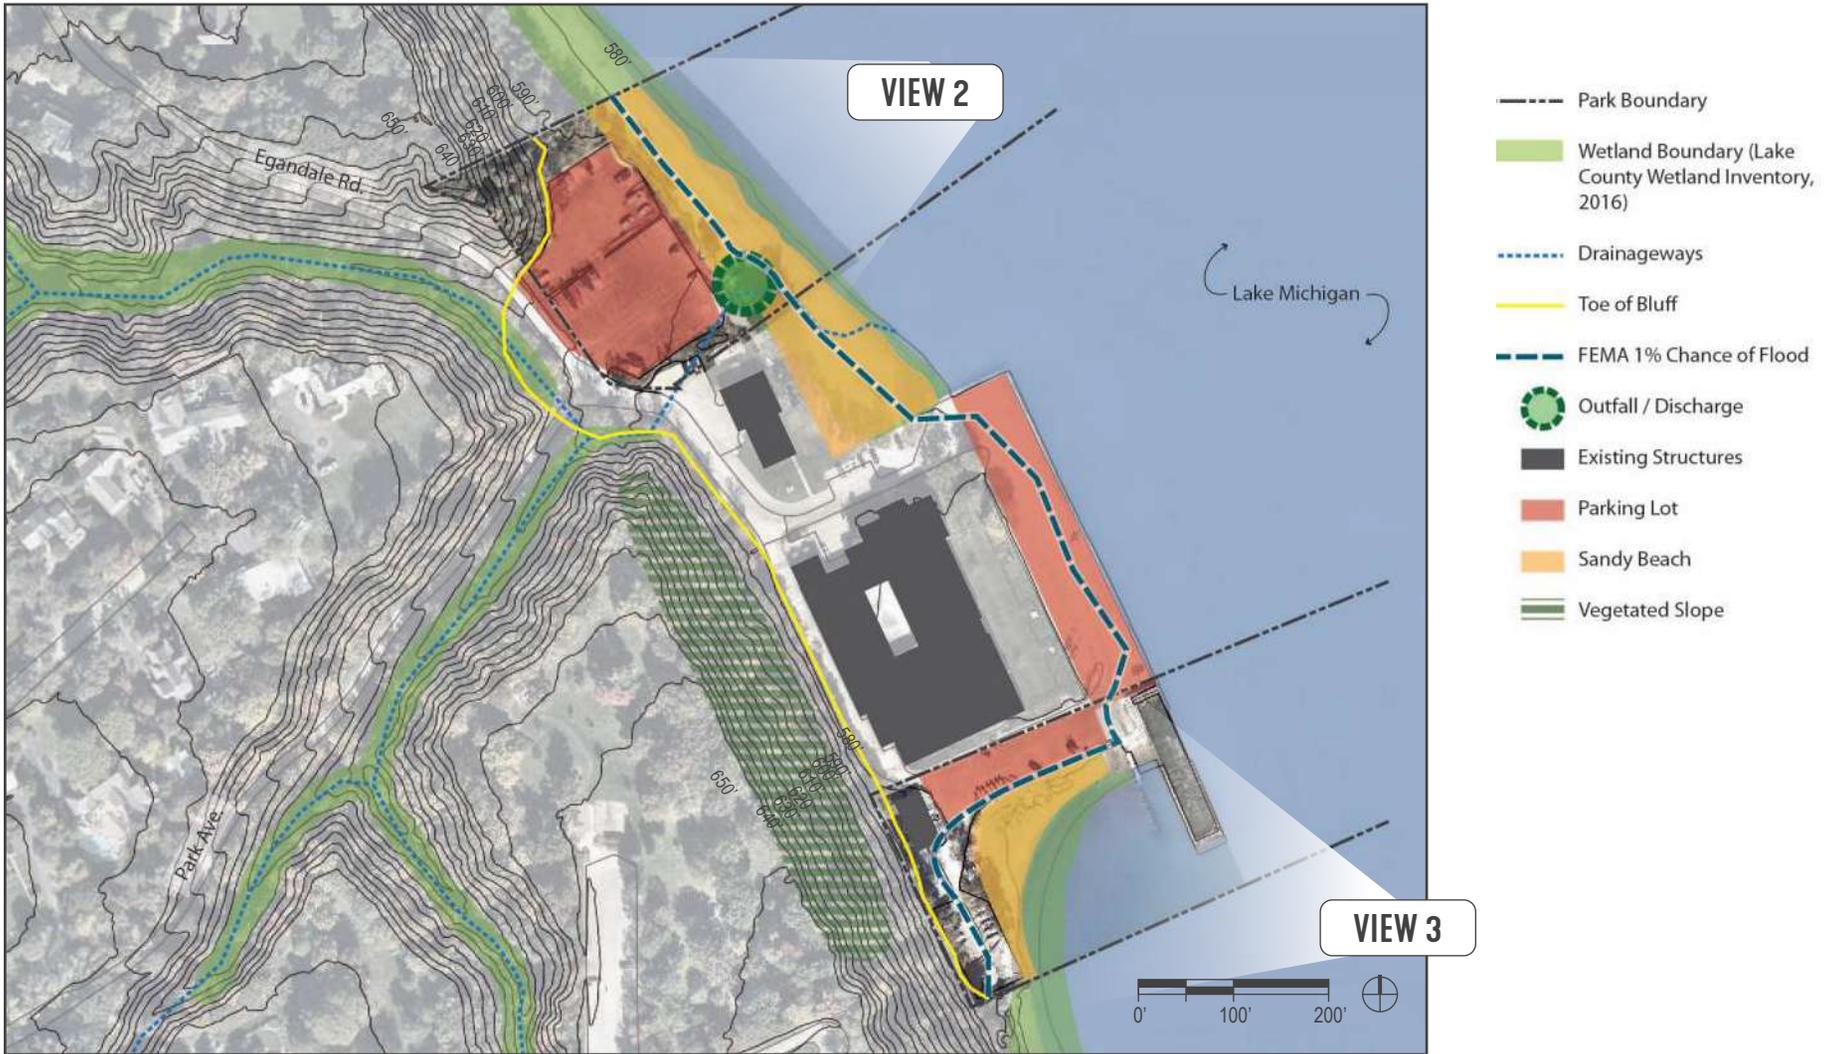
Figure 2.14 Existing Conditions at Park Avenue Boating Facility

The North Shore Yacht Club building is tucked against the bluff, south of the water plant. Historic imagery shows this area to be sandy and dry in still water conditions. Though it is provided some protection by a fronting beach, it sits at an elevation of 590 and is not without risk of flooding from high water elevation with surge and runup.

The slope of the beach directly south of the water plant is flatter, approximately 10H:1V slope, making this area good for recreation and boat storage. However, toward the southern end of the property, the beach narrows and steepens to 6H:1V – 8H:1V slope. The elevated parking pad to the south of the Yacht Club building extends into the foreshore and therefore influences the shoreline around it. Higher water levels impact the southeast corner and have resulted in damage.

The edge of vegetation on the southern side of the property appears to be currently along the 587/588 contour.

Using boat storage racks at the south beach will free up beach space for boat launching. Racks should be placed behind the FEMA 1% Chance of Flood Line (Figure 2.14).

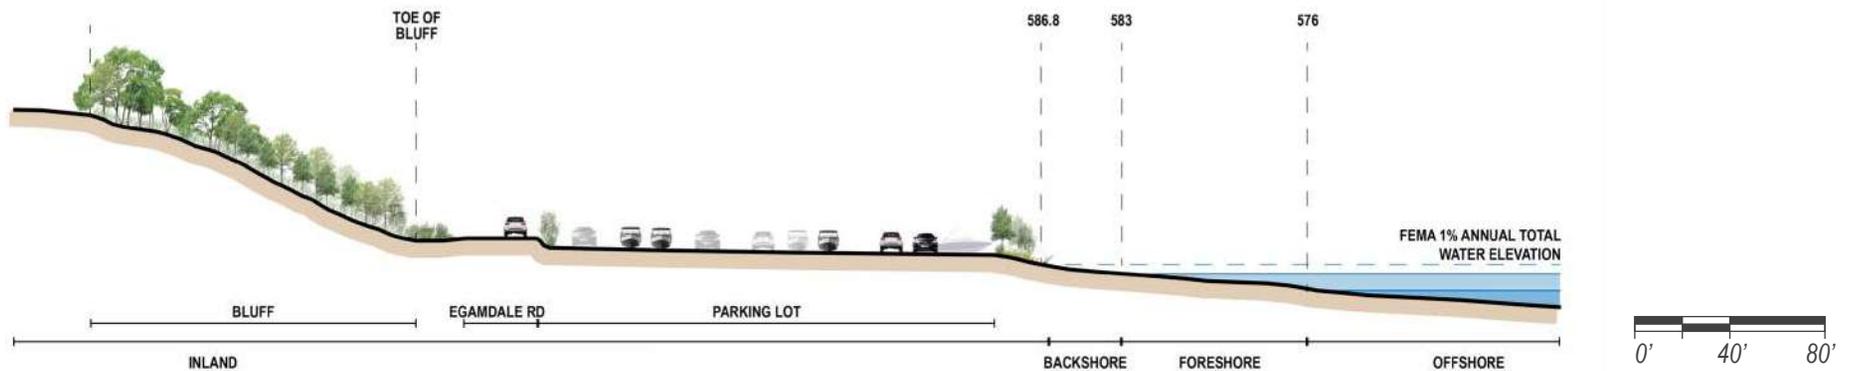
Figure 2.16 Cross Section of North Beach at Park Avenue Boating Facility

Variable water levels affected the two regions of the property differently. The northern beach, held by the protrusion of the City of Highland Park Water Plant, is angled more perpendicularly to the north and therefore experiences less longshore transport than its neighboring beaches. This makes the beach more stable throughout varying water levels.

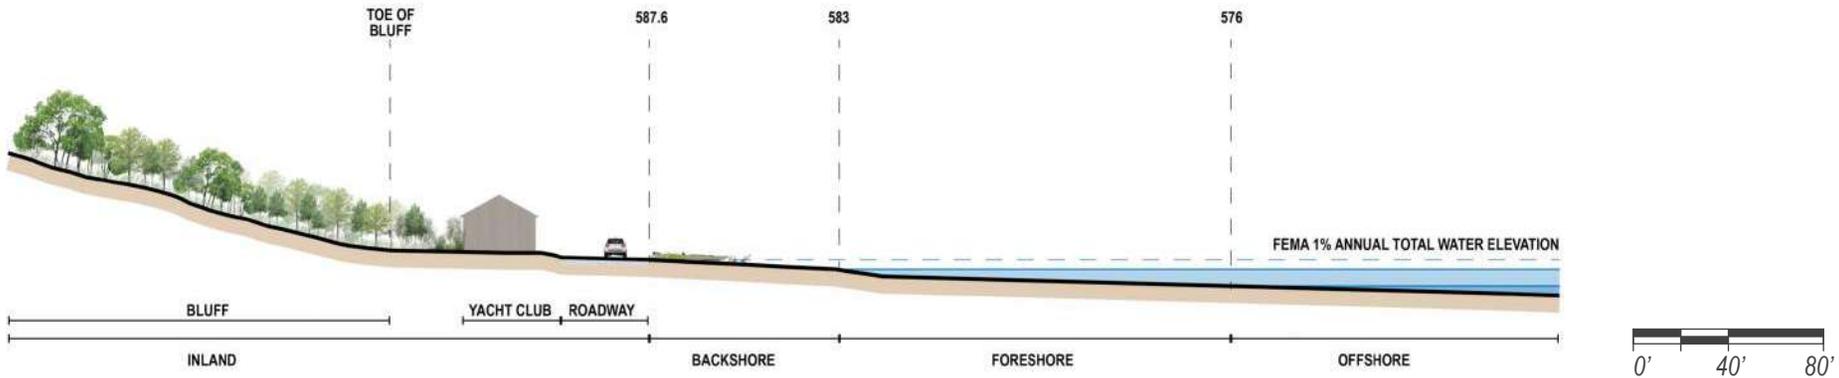
Figure 2.17 Cross Section of South Beach at Park Ave Boating Facility

further inshore. This effect will be stronger on the southern side of the property, and south of the NSYC parking pad. Without protection, the southern end of the parking pad will erode significantly, subjected to direct wave attack. While the beach area in front of the NSYC will become inundated, the still waterline at historic highest water level will not reach the building itself. However, wave runup in high water scenarios may still reach the foundation.

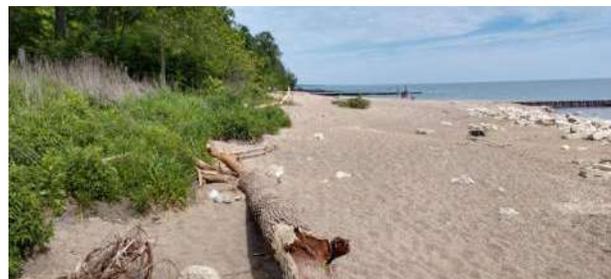
The northern beach is wider with fewer trees in the upper to middle beach portions furthest from the lake edge. The vegetation consists of low brush and dune grasses fronting larger trees located at the toe and on the slope of the bluff. (Fig 3.21 and 3.22). With the winnowing of the beach in the northern reaches of the property, this vegetation has been uprooted resulting in die-back and trees pulling away from the slope. This will further exacerbate bluff erosion.

Figure 2.21 Millard Beach viewing North

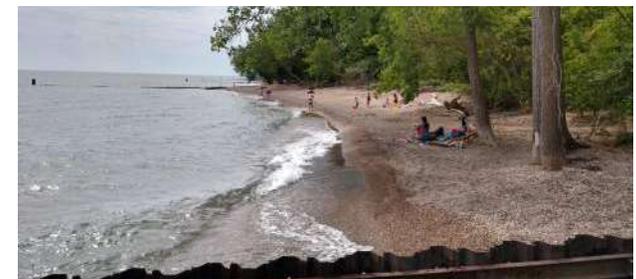
The vegetation on the south side of the outfall includes more mature trees just beyond the shoreline but within the area of runup. Damage to the bark of the larger trees is visible from wave runup carrying abrasive cobble and sand. Less mature vegetation has been completely uprooted and is strewn on the

Figure 2.22 Millard Beach Viewing South

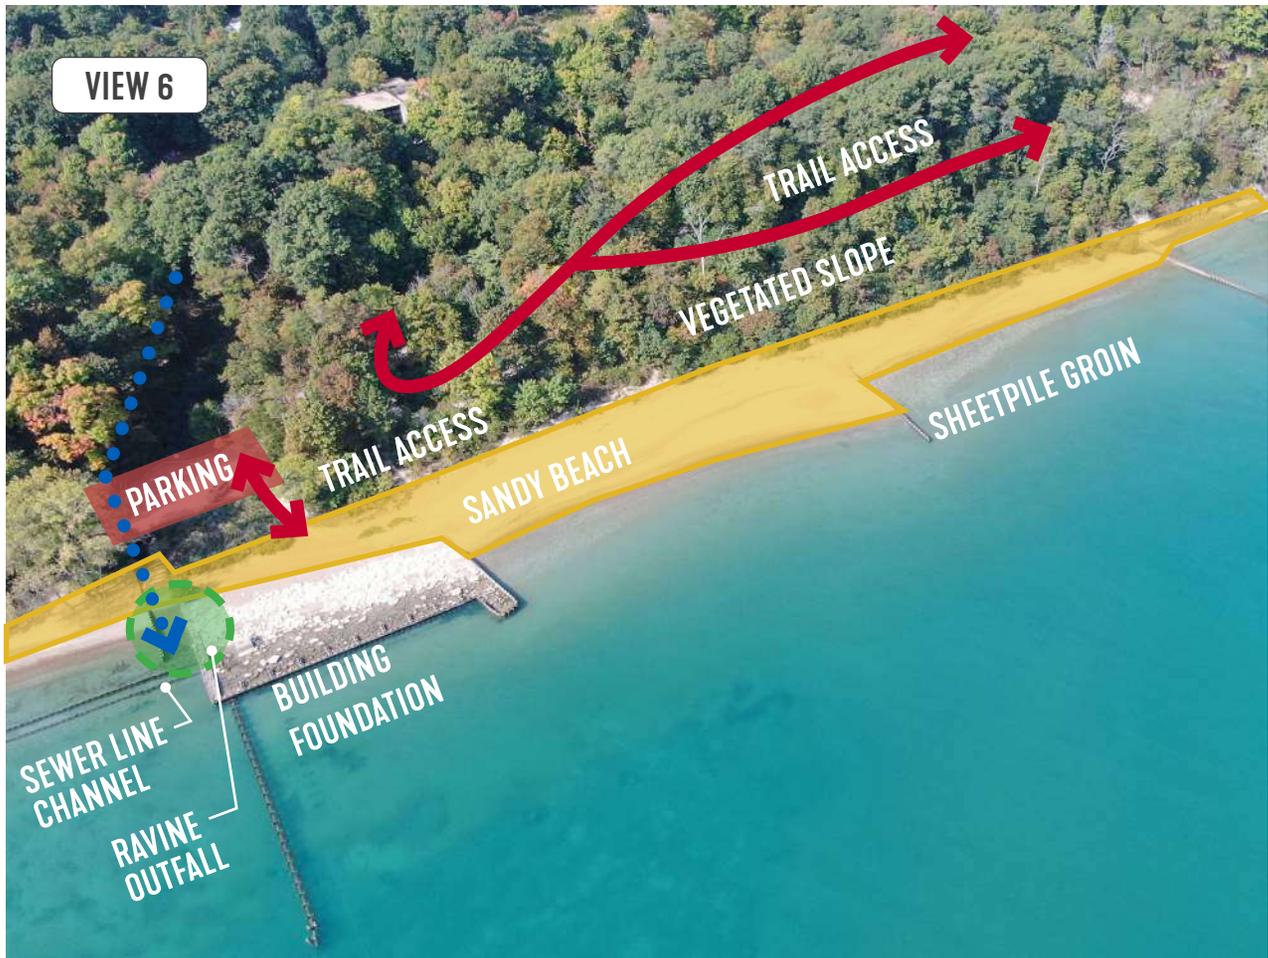
Figure 2.23 2020 Aerial Photo of Millard Beach, South

The high-water levels of 2019 & 2020 resulted in segments of bluff failure between the first and fourth groin. The compromised toe exhibits an almost vertical face which is inherently unstable. Vegetation roots are fully exposed in some areas. While the primary cause of the bluff failure was wave attack at the toe and ground saturation, the dense tree canopy cover and open soft sediments contributed to the failure. Bluff face vegetation will continue to pull on the topsoil layer exposing the soft sediments below. The combination of weakening of vegetation roots as the plant withers and stormwater cutting into the soft soils will lead to a full bluff face collapse as the slope attempts to correct itself back to a stable position. This can happen immediately or may take years but without intervention, the current slope will break and slump.

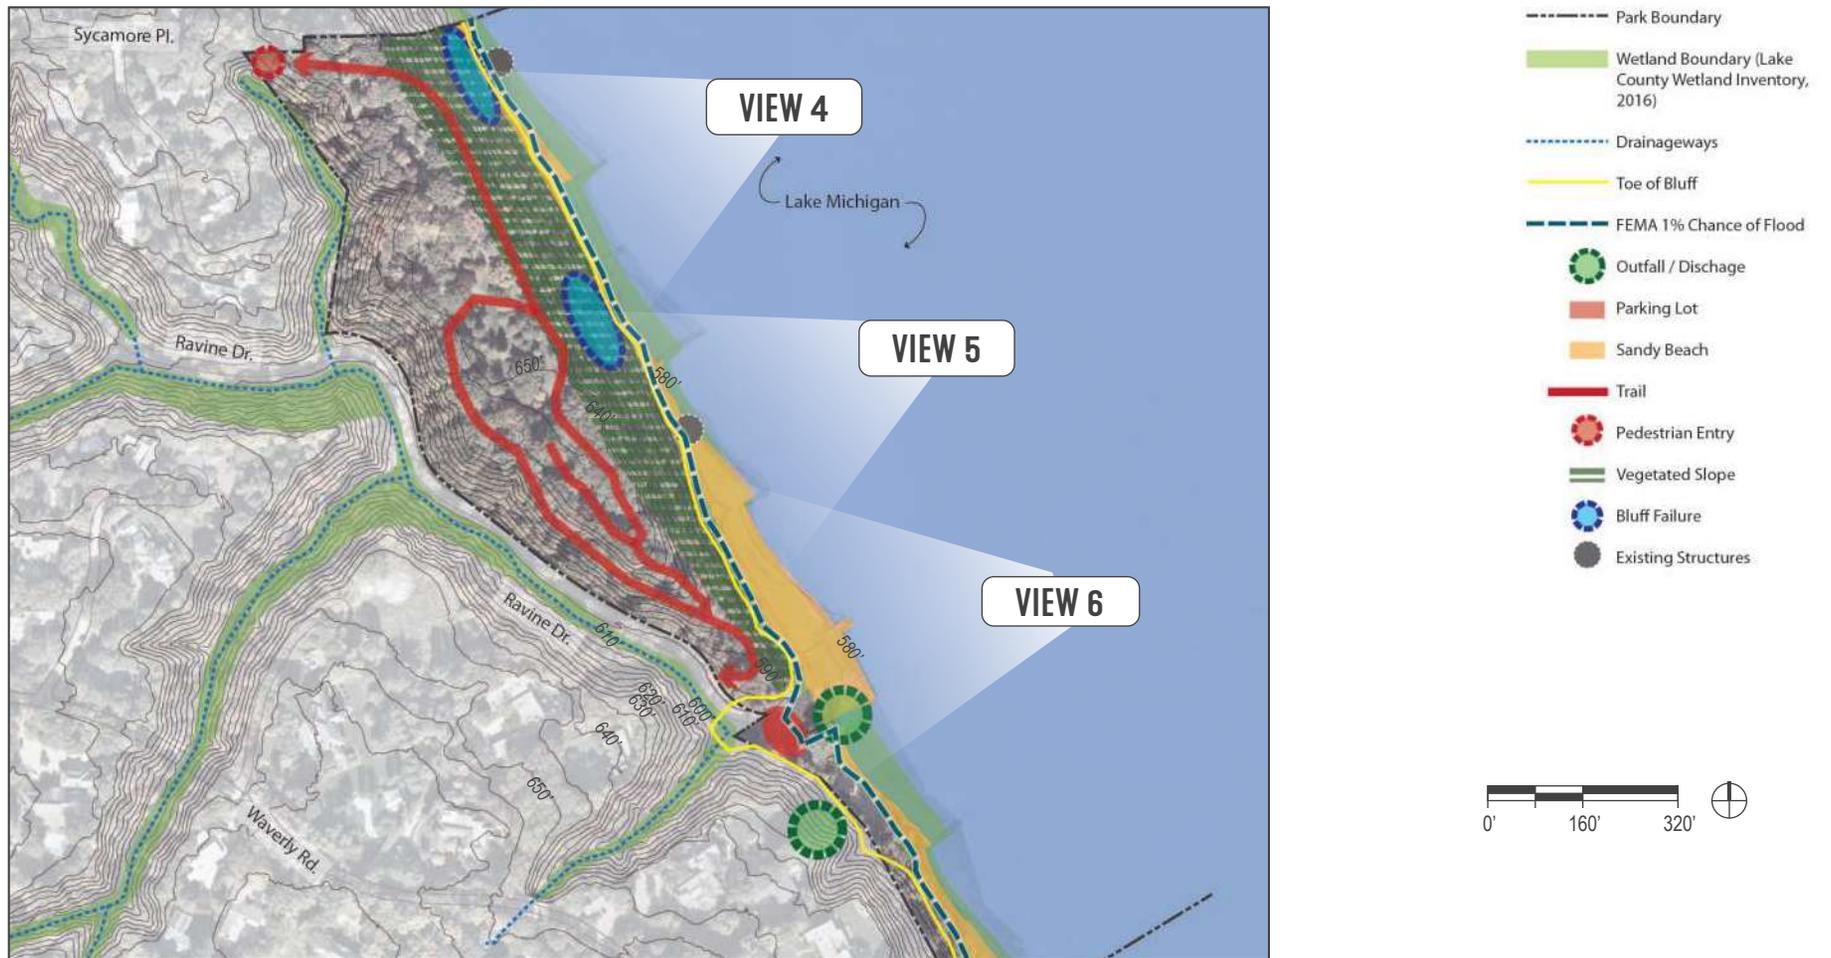
Figure 2.24 Existing Conditions at Millard Beach

Despite the high-water levels of 2020, wide areas of dry beach adjacent to the parking lot are available for passive recreation.

Millard Beach has signage informing users of features of the beach and park located at the parking lot. The bluff on the south side is privately owned and marked. Signs and fencing delineate the boundary.

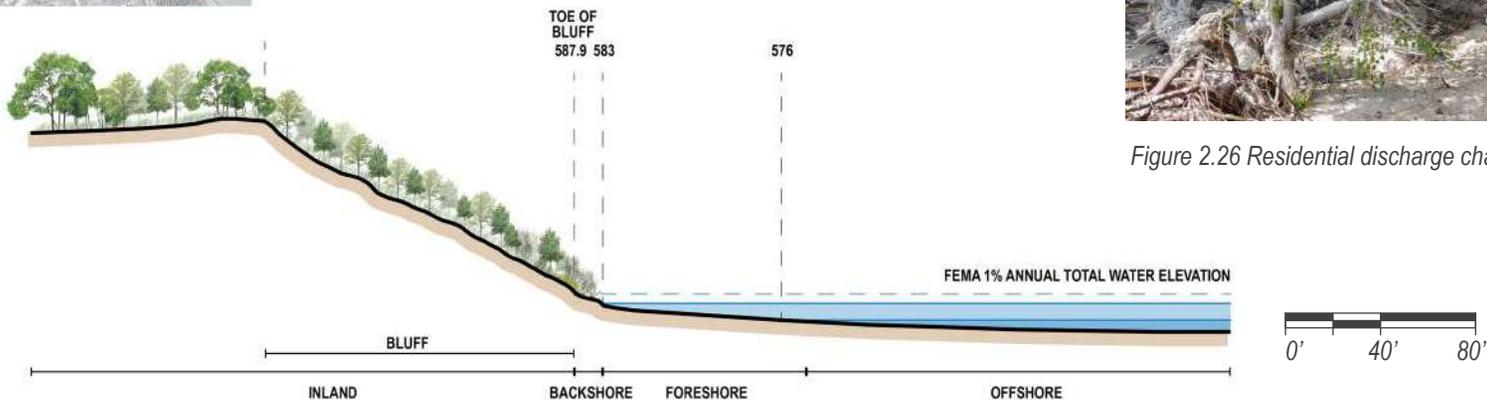
Figure 2.25 Cross Section of Millard Beach

The height of runup and influence of waves at the beach is estimated to be 587.9. Given the toe of bluff is located at roughly the 587 contour, this puts much of the bluff in jeopardy of toe erosion. Review of the 2017 survey shows areas where the toe of bluff starts at the 585 contour. Not coincidentally, these areas are where bluff toe failure can be seen in 2020 aerials.

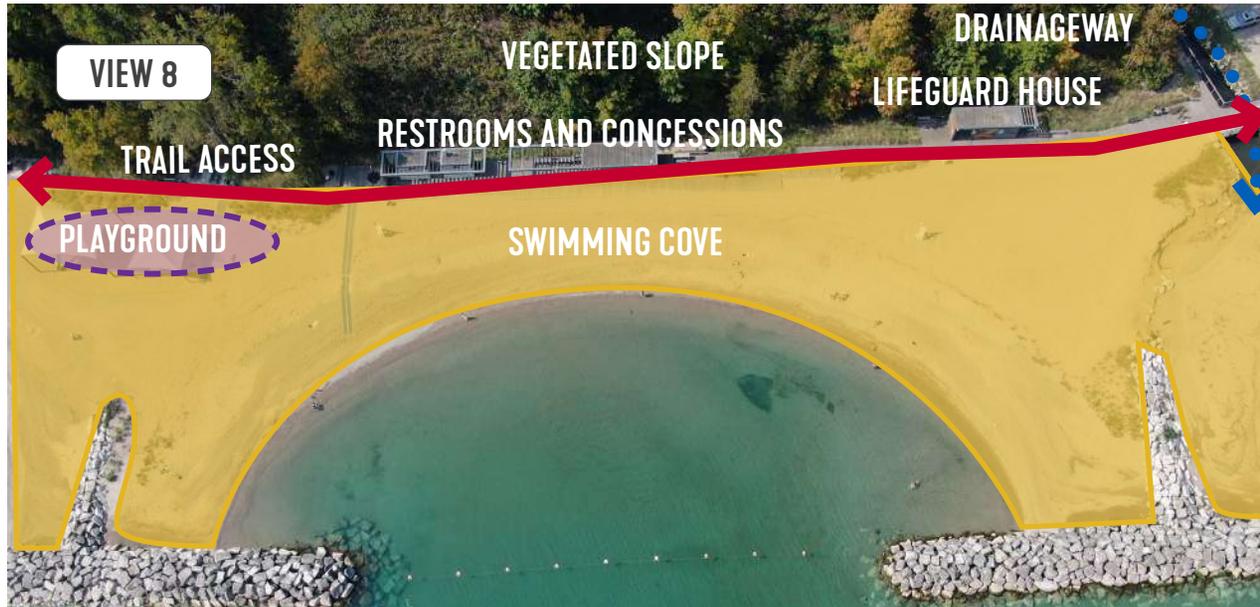
Figure 2.30 Rosewood Beach Swimming Cove, 2020

When the redesigned Rosewood Beach was opened in 2015, it featured shallow beach slopes. As water levels started to rise, storm intensity and wave penetration into the coves increased. This caused the beaches to steepen in response. A monitoring program of the shoreline found that sand was pulled offshore during strong storm events at high water and created low-lying

Responding to the significant flattening and removal of placed beach sands, the PDHP placed nourishment sands in all three

coves between fall 2019 and spring 2020. Two types of sand were placed at Rosewood Beach: 'Torpedo' sand, which is the same sand placed during the original construction, and 'Birdseye' sand, which is a coarser sand with larger grain sizes. The benefit of increasing the grain size is it limits beach slope flattening and materials being pulled offshore. Nourishment within Rosewood Beach consisted of 'Birdseye' sands placed in the Interpretive Cove, 'Birdseye' sands placed within the Recreation Cove, and a mixture of 'Birdseye' and 'Torpedo' sands placed within the Swimming Cove. Since placement, native and placed sands have mostly mixed. However, the heavier sands have built up on the south side of the Interpretive Cove where wave energy removes the softer sediments. This had led to the occasional blockage of the Rosewood Ravine outfall which has difficulty naturally clearing a pathway connection to Lake Michigan.

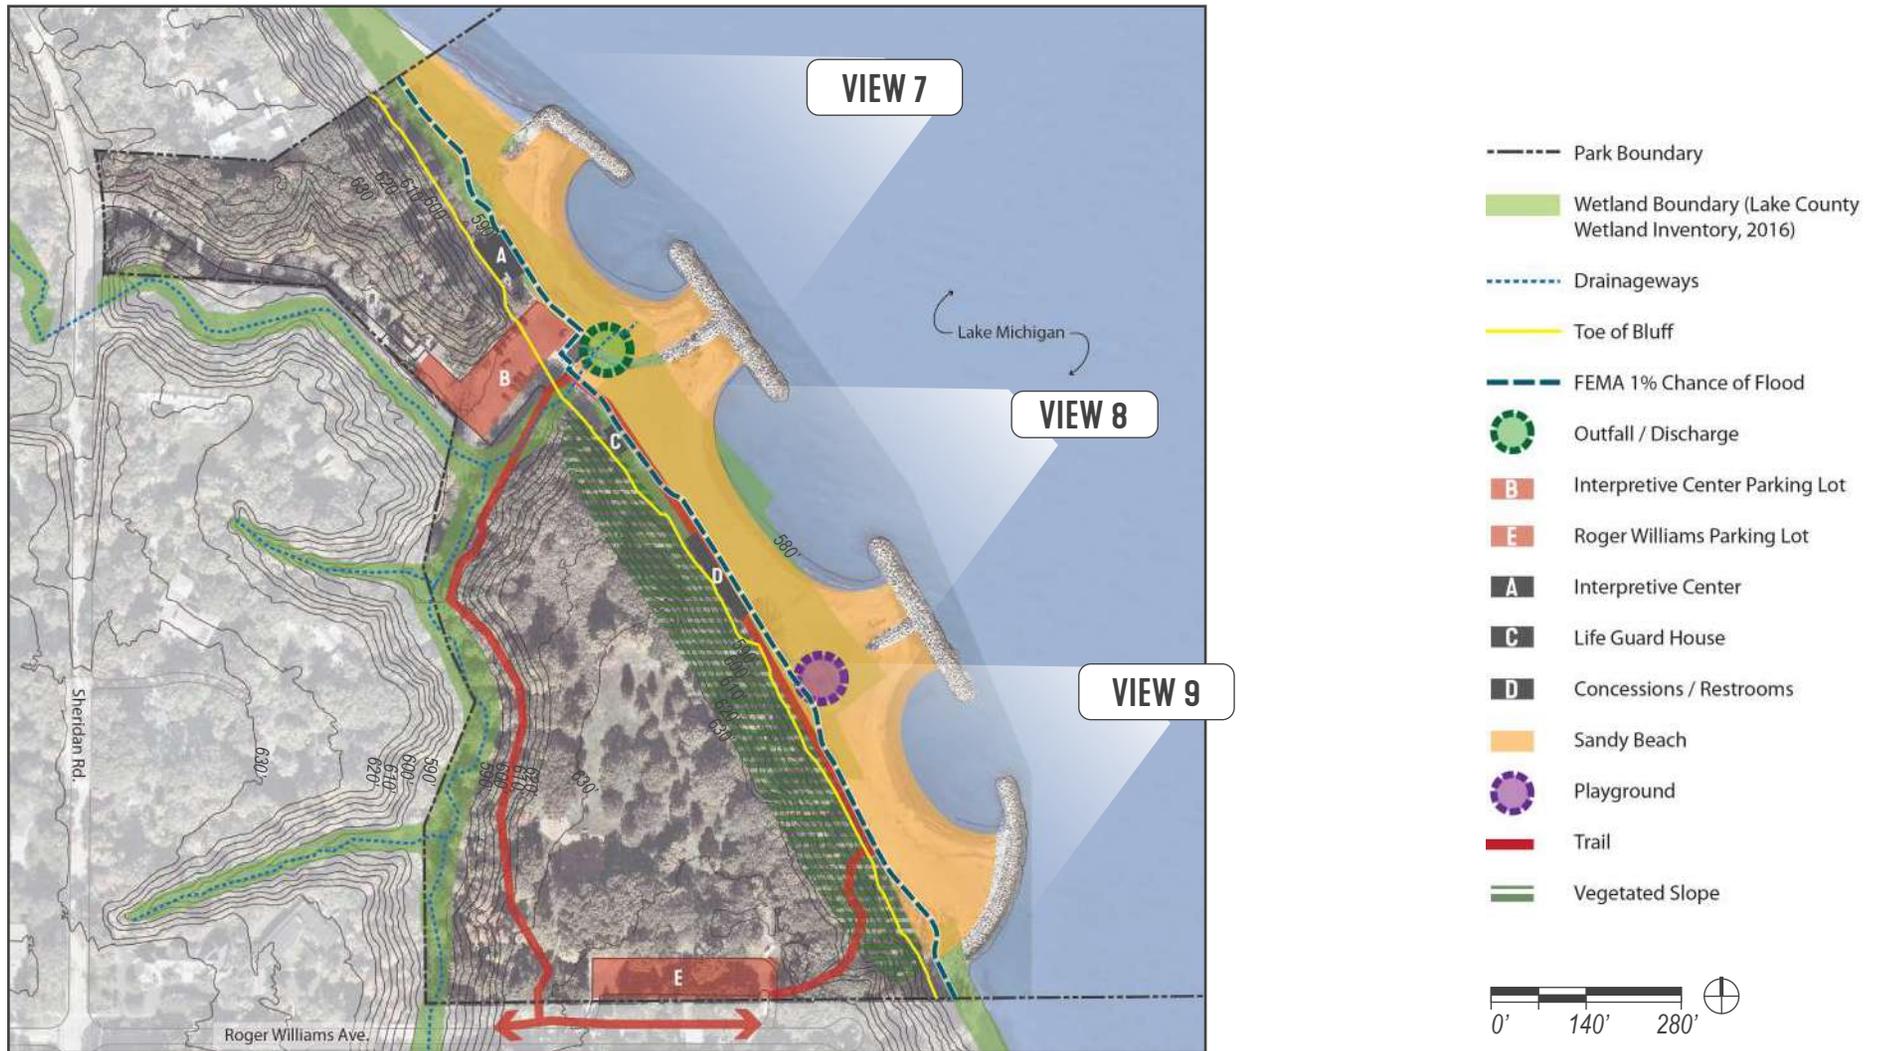
Figure 2.33 Existing Conditions at Rosewood Beach

between the toe of bluff and boardwalk with establishment of a healthy suite of desirable native species. Grasses were planted throughout Rosewood Beach in select flatter, sandy areas. Some of these areas were not as successful at establishment; high water levels cut away the beach and beach users, likely unaware of restoration efforts, trample areas of residual plantings.

Areas west of the bridge, over the ravine creek discharge, have been damaged by storm surges.
