MILLARD BLUFF SLOPE STABILITY ANALYSIS

MILLARD PARK

Highland Park Lake County, Illinois

July 2, 2021

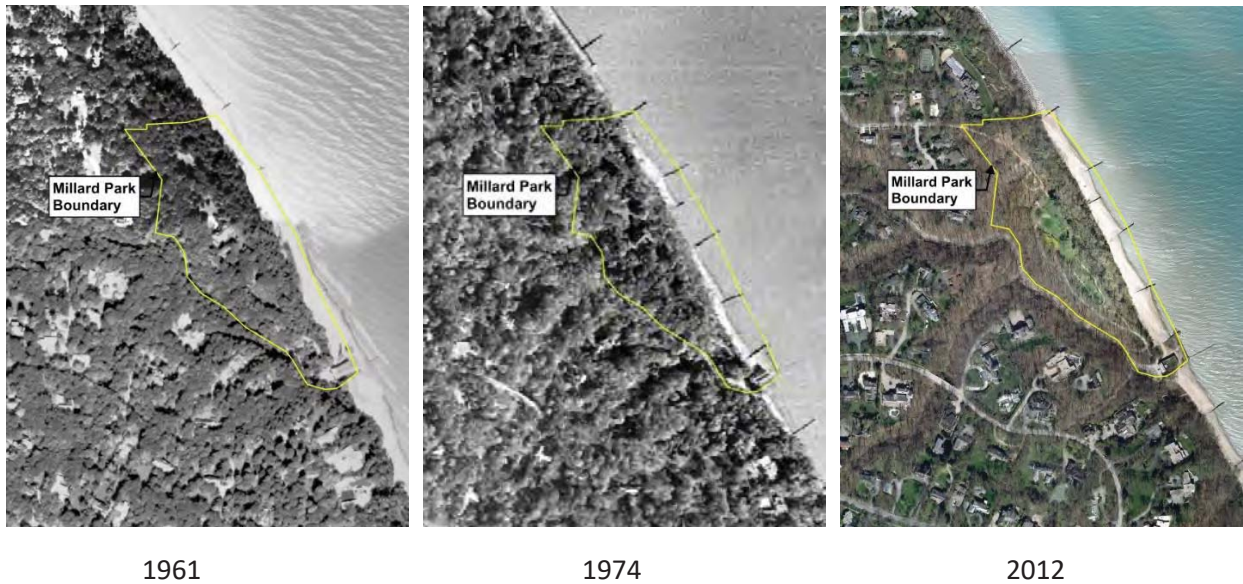
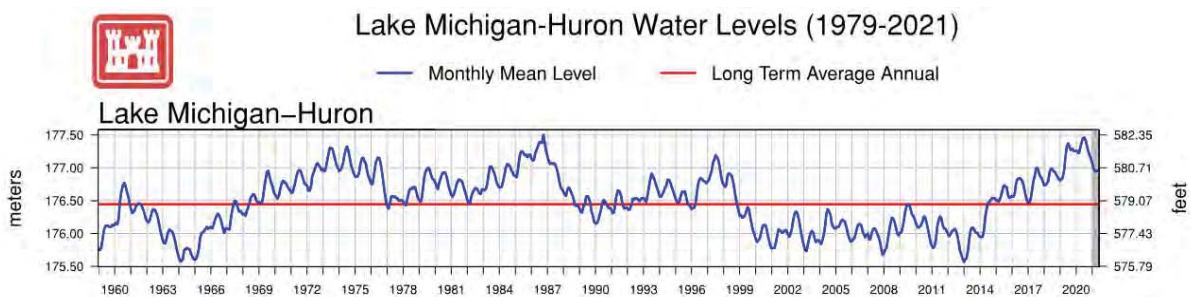
Figure 1.11 Historical Aerial Photographs with Corresponding Water Level Elevations.

Looking at past historical aerial photographs it can also be seen that the 5 main pile driven jetty walls were already in place back in 1939 with a 6th added sometime between 1961 and 1974. The photos throughout the years clearly show that the jetty walls do have a positive impact on preserving the beachfront and presumably the bluff as well. The aerial photographs clearly show that the jetties minimize sand loss and help preserve beachfront, especially during high lake levels.

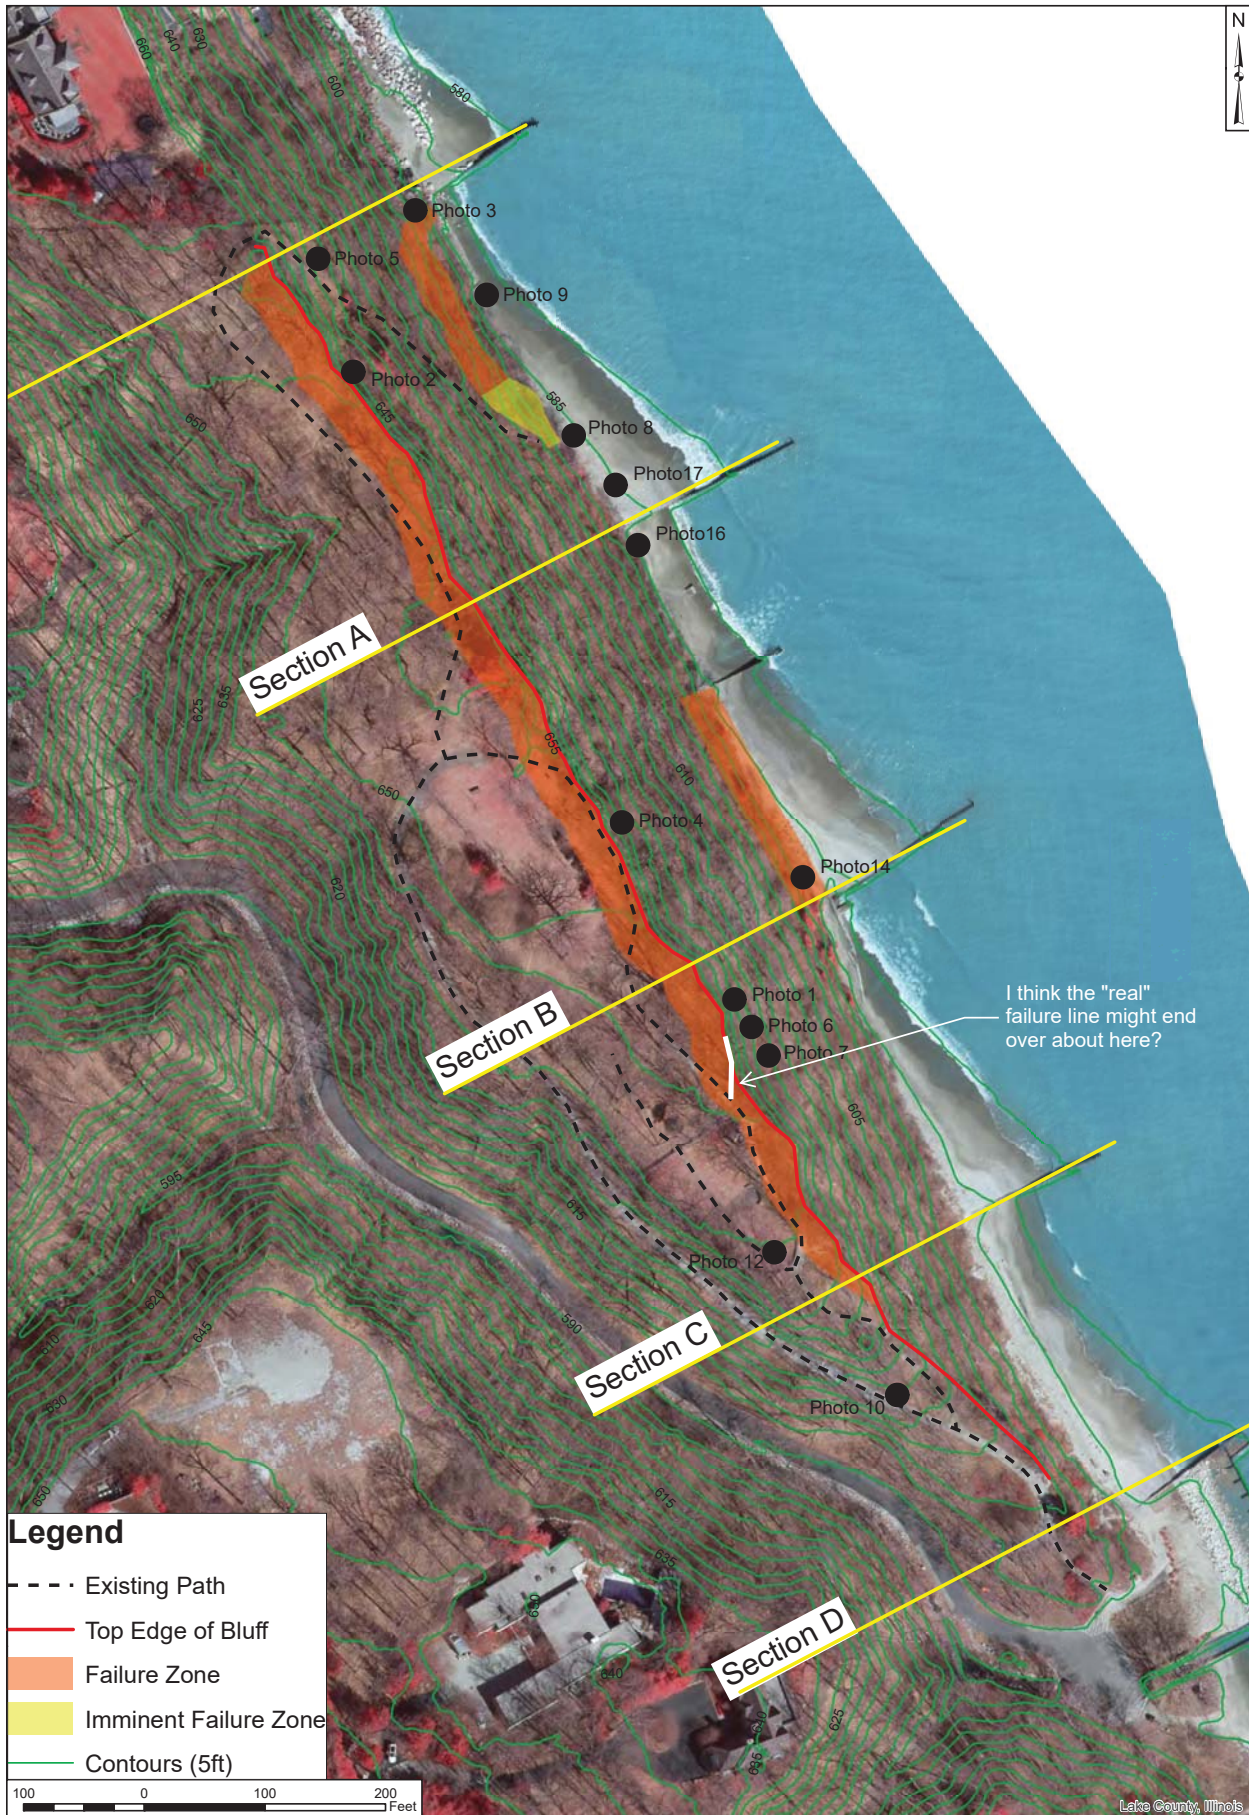
Visio, Vertere, Virtute... "The Vision To Transform With Excellence"	PROJECT NO.: 210275 CREATED BY: SAV DATE: 06/29/2021 SCALE: See Scale Bar	CLIENT: Park District of Highland Park 636 Ridge Road Highland Park, IL 60035 BASE LAYER: Lake County Aerial (2018)	TITLE: SLOPE FAILURE ZONES Millard Park Bluff Slope Stability Analysis Highland Park	EXHIBIT: 2.0
	Lake County, Illinois

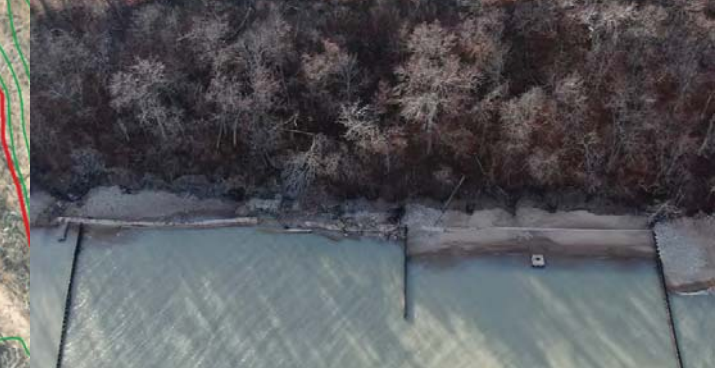
In addition to the sheet pile (jetty) walls a concrete seawall was constructed between the two main sheet pile jetties bounding Section B. Portions of the wall are damaged and allow overtopping water to flow back towards the lake, scouring out the sand behind the lowered concrete wall. Looking at aerial photos of this area (**Figure S.1** below) it is clear that in locations where the seawall is still intact the bluff appears to have somewhat less failure and erosion. Other than the sheet pile jetties and broken section of concrete wall, no existing structures appeared to be in place to prevent erosion at the toe of the bluff.

Visio, Vertere, Virtute... "The Vision To Transform With Excellence"	PROJECT NO.: 210275 CREATED BY: SAV DATE: 06/29/2021 SCALE: See Scale Bar	CLIENT: Park District of Highland Park 636 Ridge Road Highland Park, IL 60035 BASE LAYER: ESRI Basemap Aerial	TITLE: CONCRETE SEAWALL REPAIR Millard Park Bluff Slope Stability Analysis Highland Park	EXHIBIT: 5.0
	N:\2021\210275\Drawings\ArcGIS\NR\Exh5_Seawall Repair.mxd
